**Shawville Arena**  
**Limited Building Condition Assessment**  
**and Summary of Systems**

November 2024

JLR No.: 32824-000

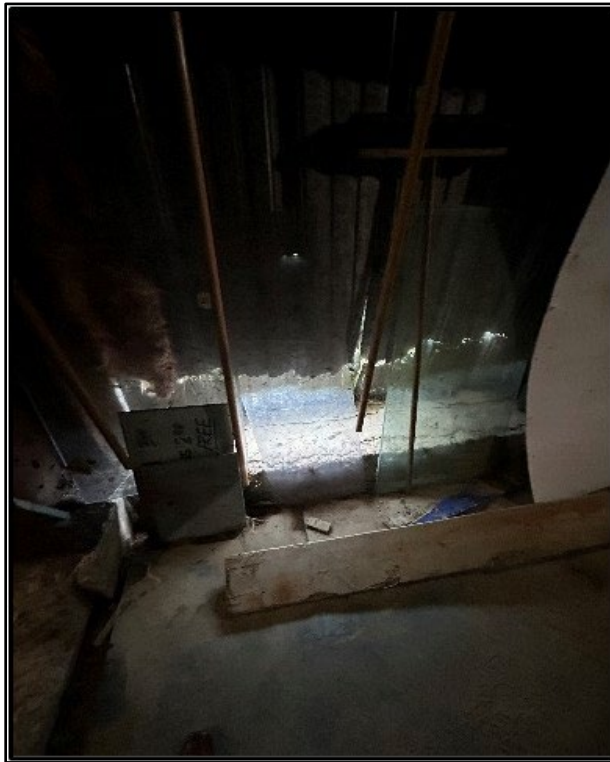
**Photo 2: Section loss at exterior cladding seen from inside the structure.**

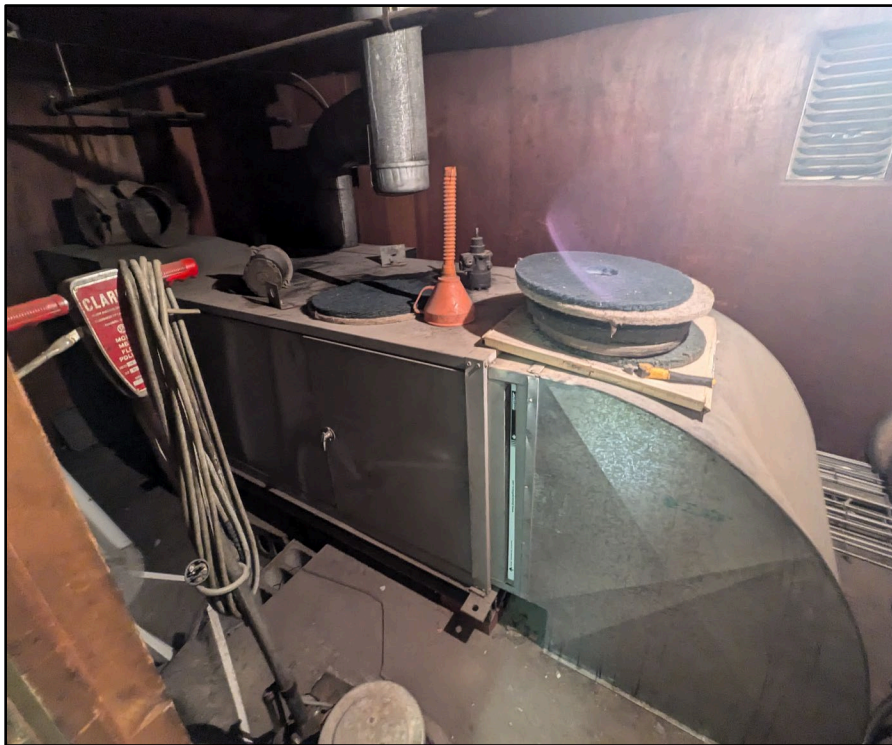
**Photo 16: Jackson and Church Furnace**

There is one Jackson & Church oil-fired furnace located on the second floor serving the lobby and dressing room 1. The age of the furnace could not be determined at the time of the visit. The expected useful life for this type of equipment is 18 years. Judging by the amount of dust and it is expected that it was installed more than 18 years ago, and therefore should be considered for replacement.
