**JLR No.: 32824-000.1**  
**Revision: 01**

**MUNICIPALITY OF SHAWVILLE**

# **Pre-Feasibility Report**

## **Shawville Arena, Municipality of Shawville**

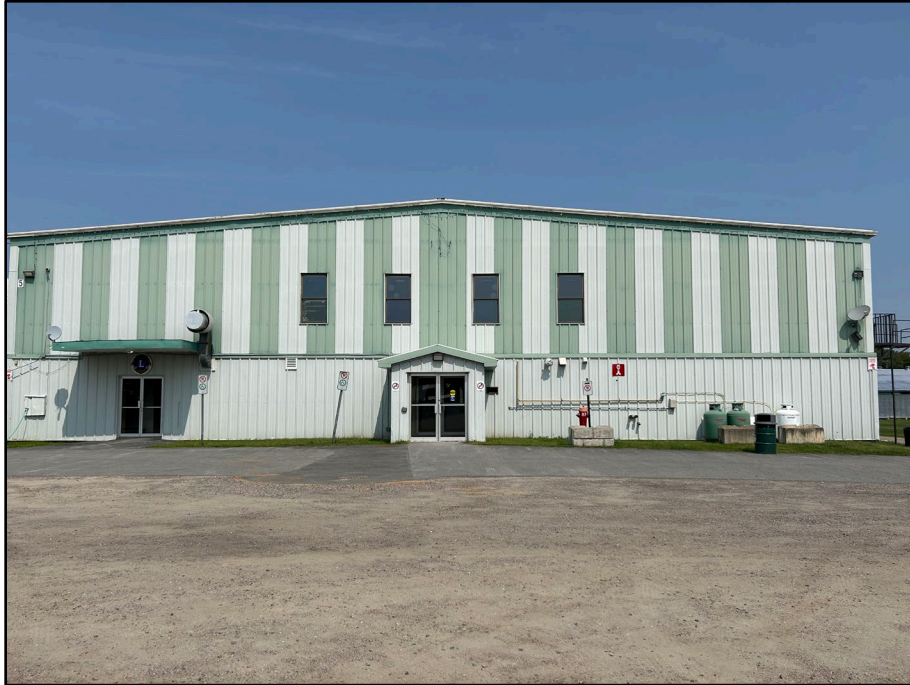
**Photo 1: Front face of entrance structure.**

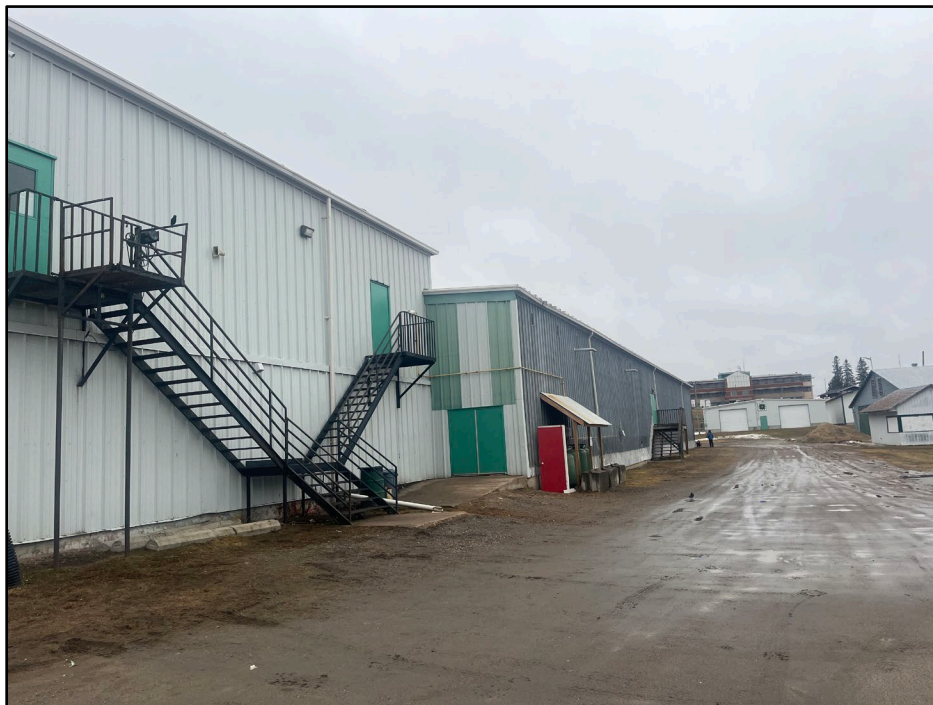
**Photo 2: East face of structure.**

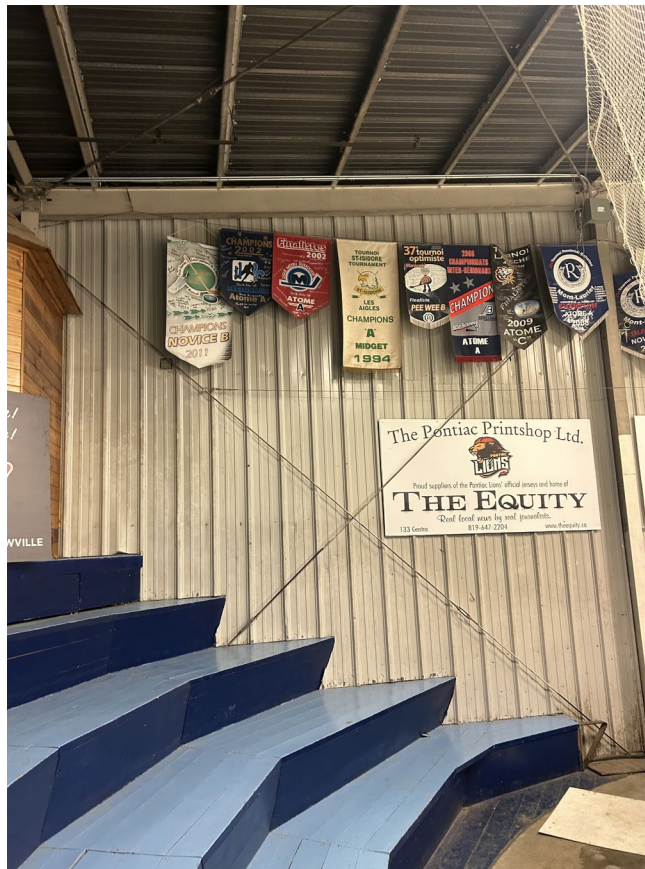
**Photo 10: Cross bracing at back wall of arena.**

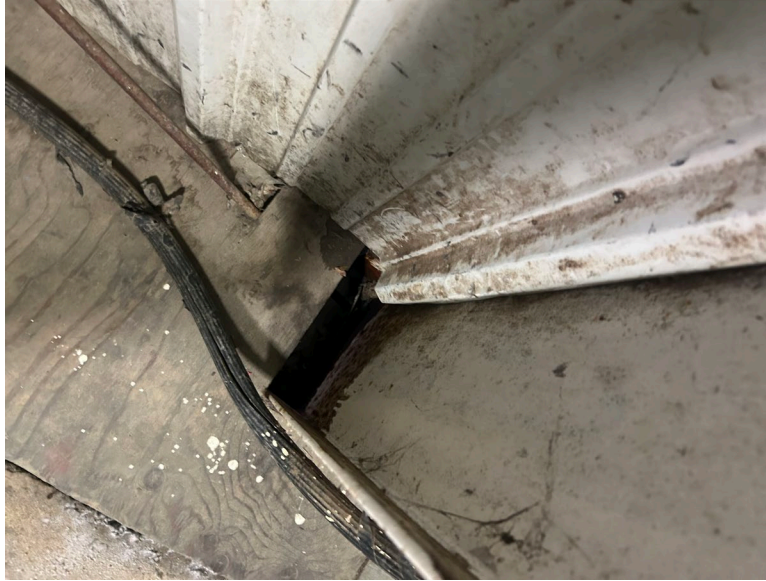
**Photo 11: Opening observed at interior steel cladding wall.**

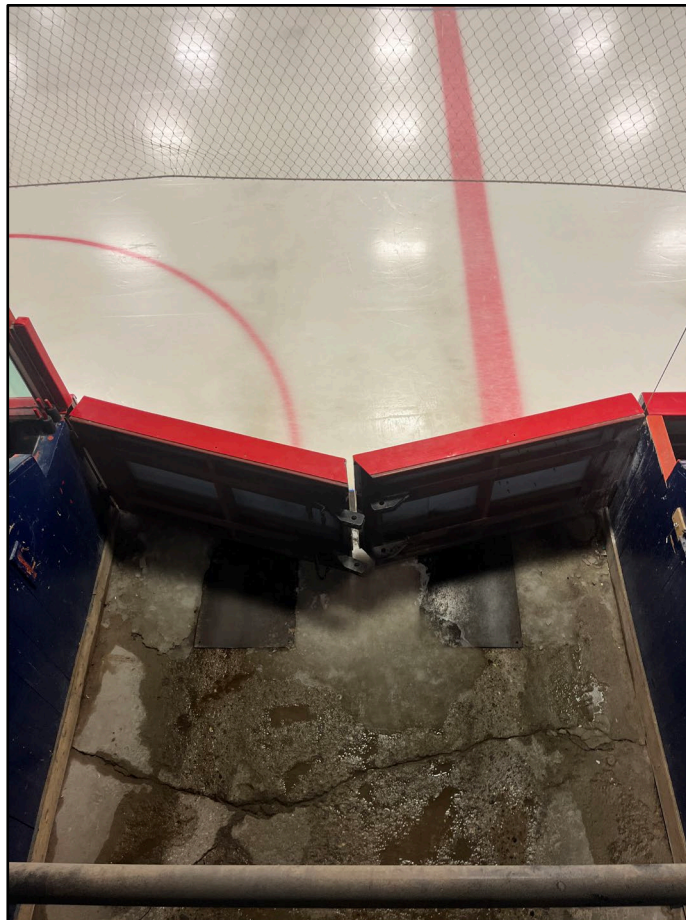
**Photo 12: Exposed base slab at Zamboni entrance.**

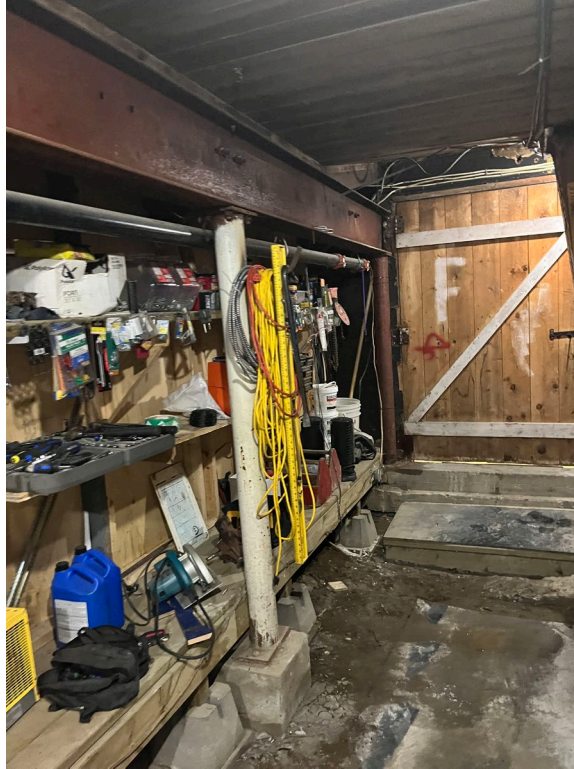
**Photo 13: Exposed base slab underneath west bleachers.**

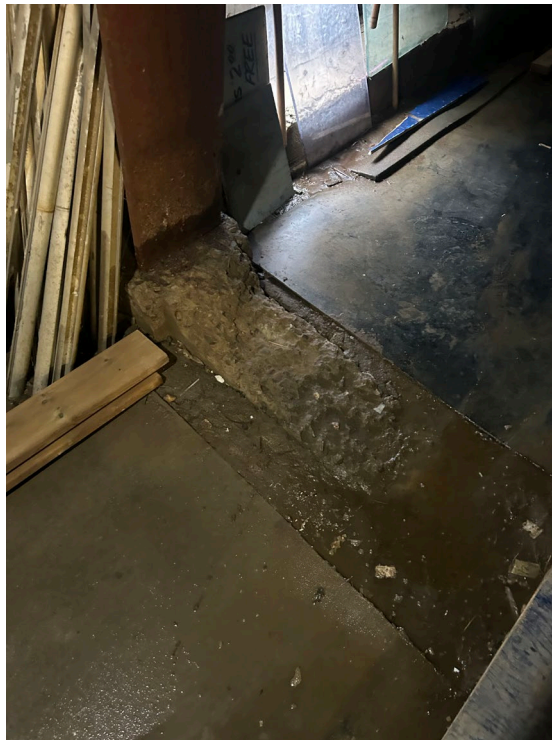
**Photo 14: Exposed deteriorated base slab underneath west bleachers.**

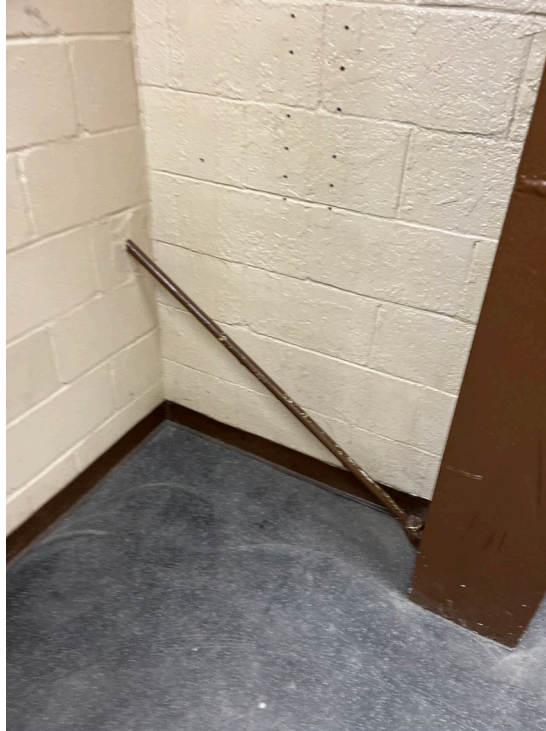
**Photo 21: Cross bracing observed to go through concrete block wall.**

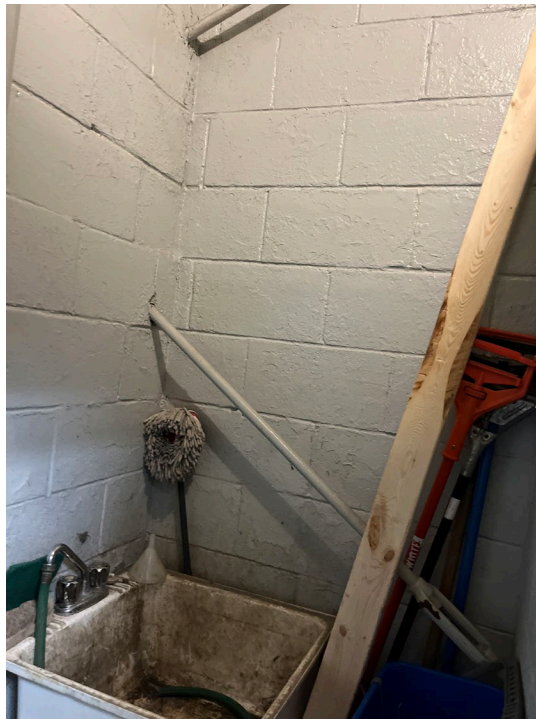
**Photo 22: Cross bracing observed to go through concrete block wall.**

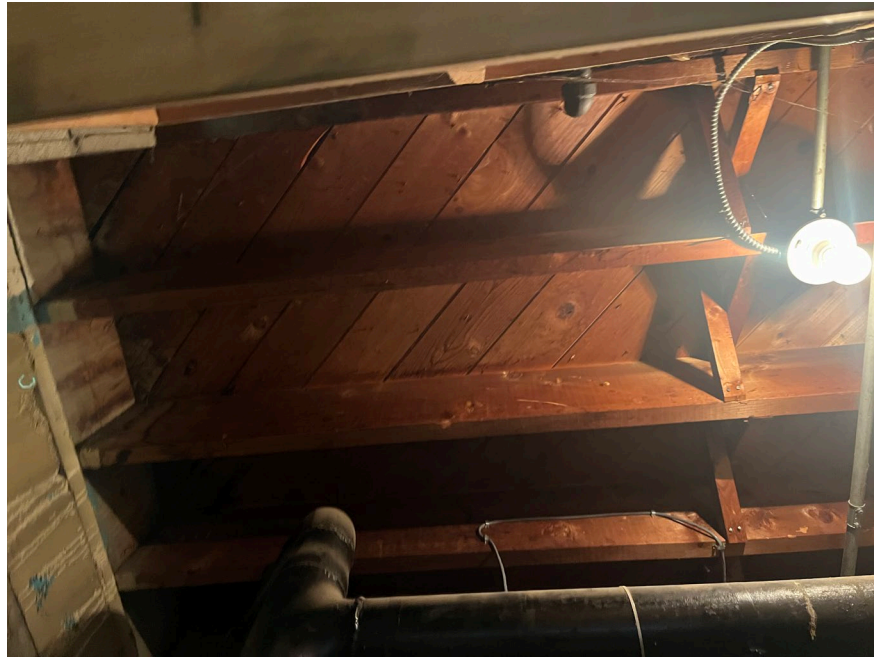
**Photo 23: Wood beam elements under mezzanine.**

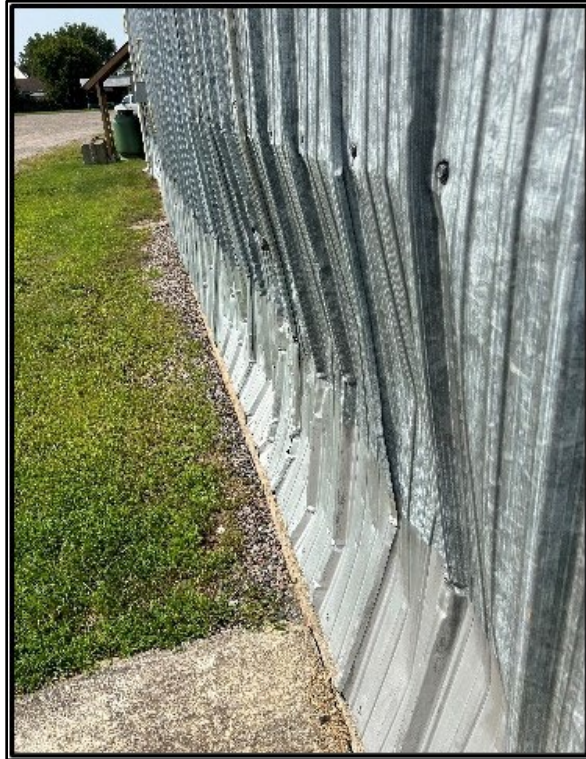
**Photo 3: Deformed exterior cladding on east side of rink structure.**

- 1) The existing cladding along the arena portion is in poor condition with areas of visible weathering and damaged sections at the bottom perimeter where daylight is observed from within. It is recommended to remove and replace exterior cladding.

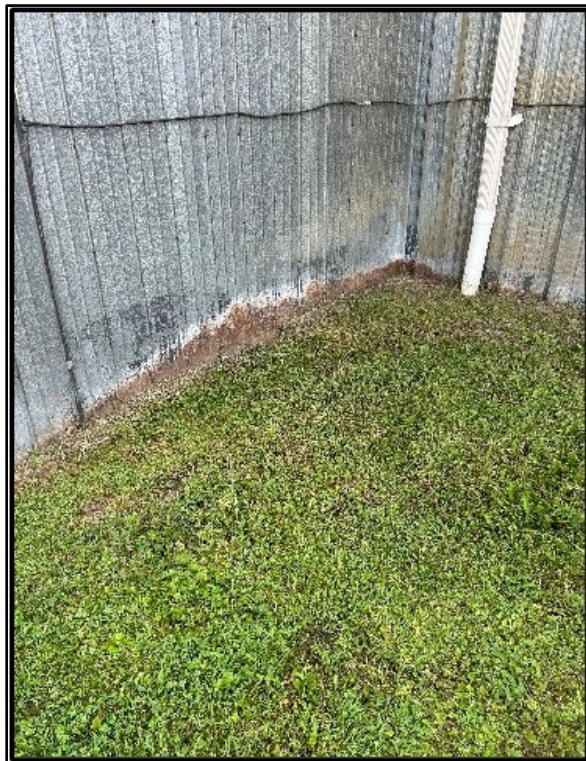
**Photo 4: Exterior cladding with visible rusting.**

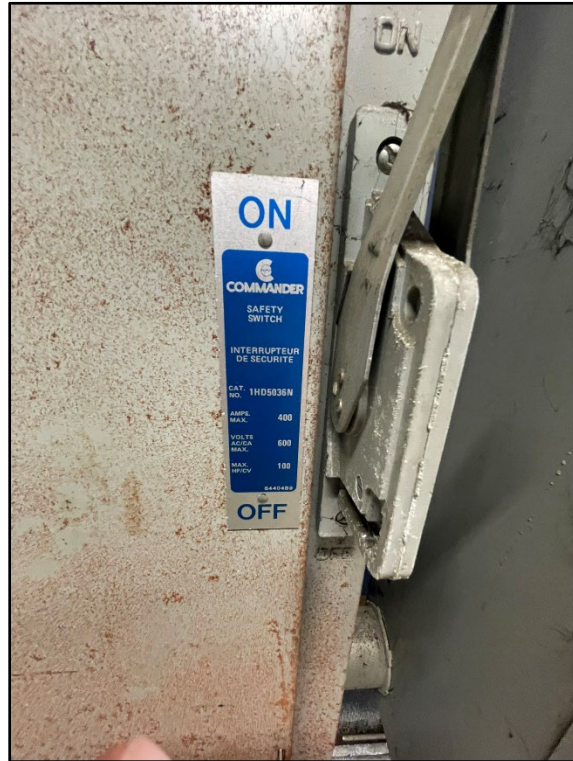
**Photo 7: Equipment Rust**

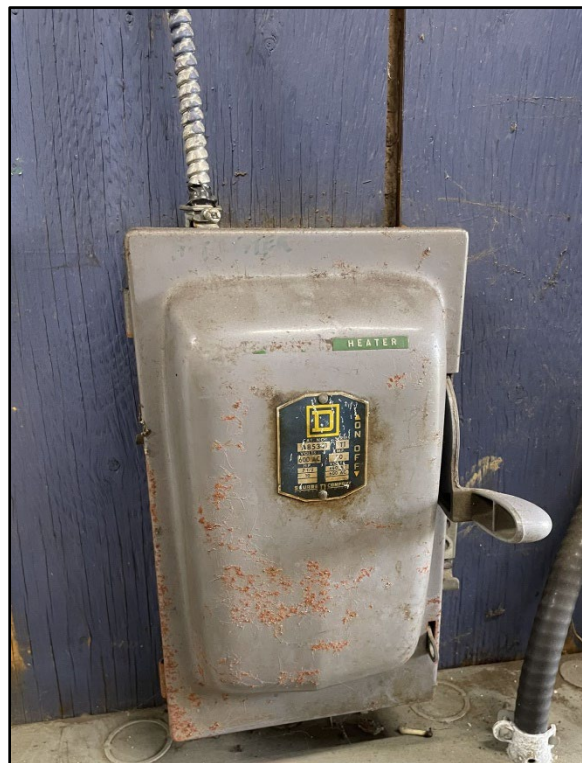
**Photo 8: Disconnect Rust**

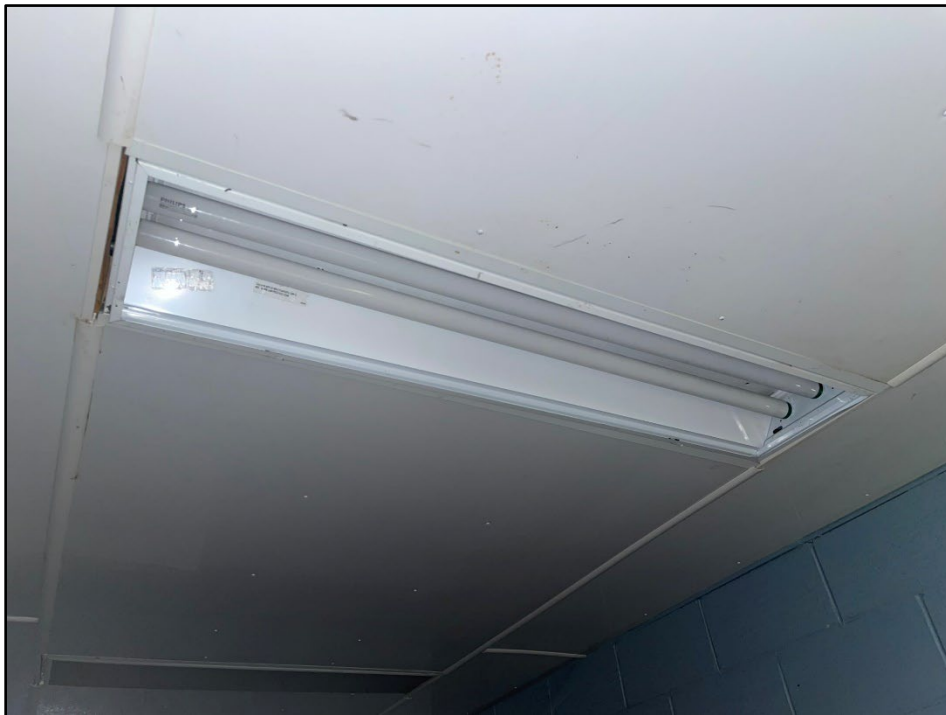
**Photo 14: Damaged Lighting Fixtures**

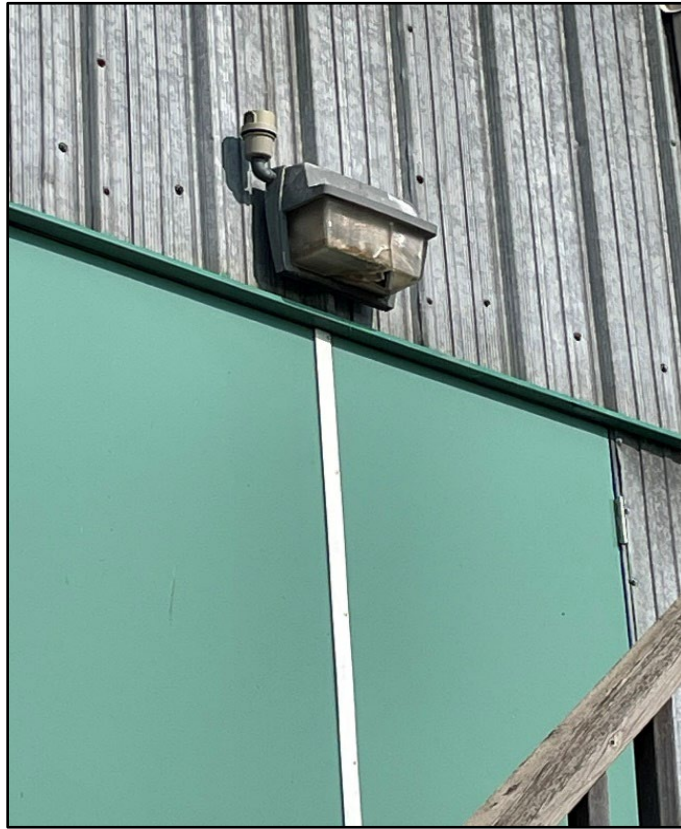
**Photo 17: Damaged Wall Pack**
