**Shawville Arena**  
**Limited Building Condition Assessment**  
**and Summary of Systems**

November 2024

JLR No.: 32824-000

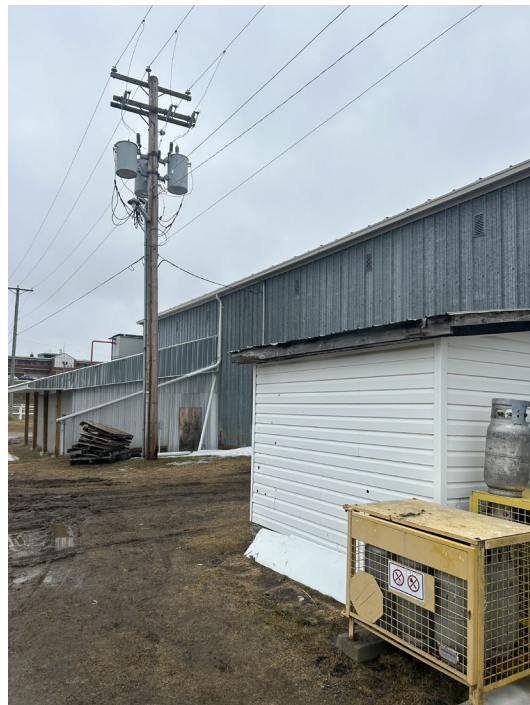
**Photo 4: West face of structure facing north.**

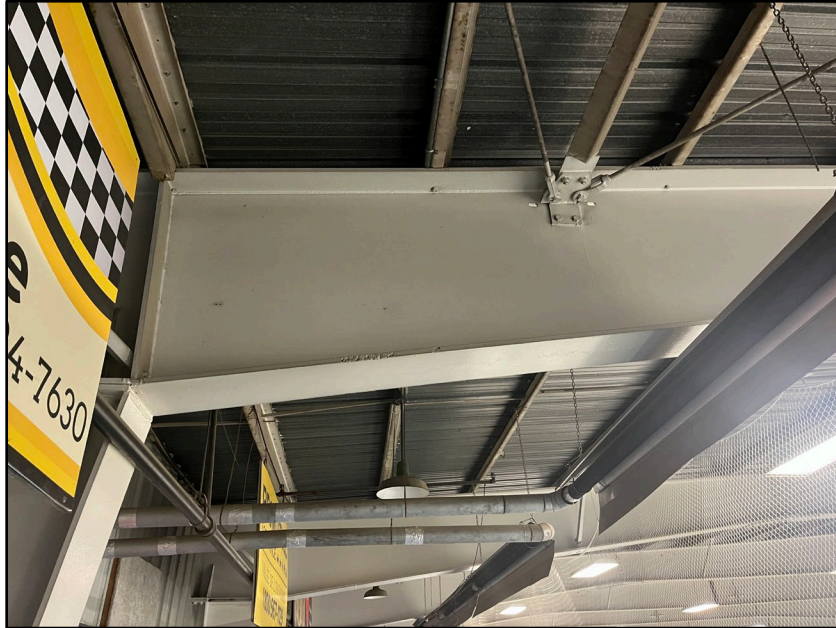
**Photo 9: Steel roof beam.**

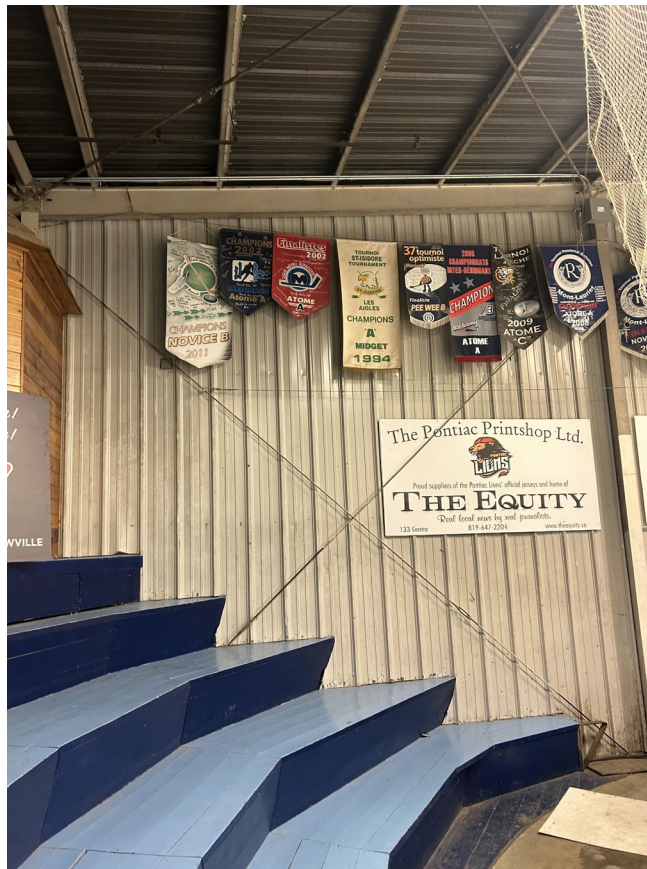
**Photo 10: Cross bracing at back wall of arena.**

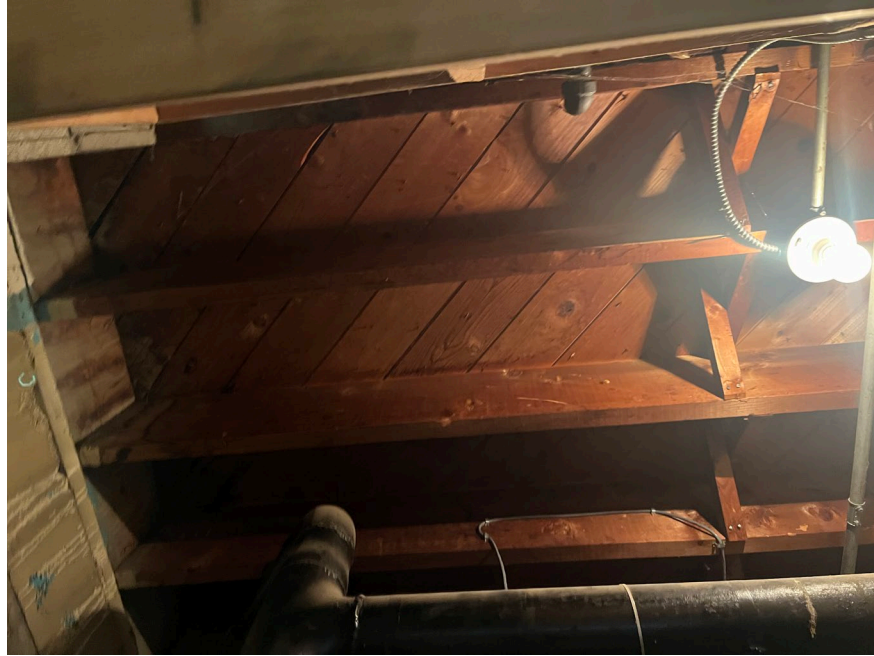
**Photo 23: Wood beam elements under mezzanine.**

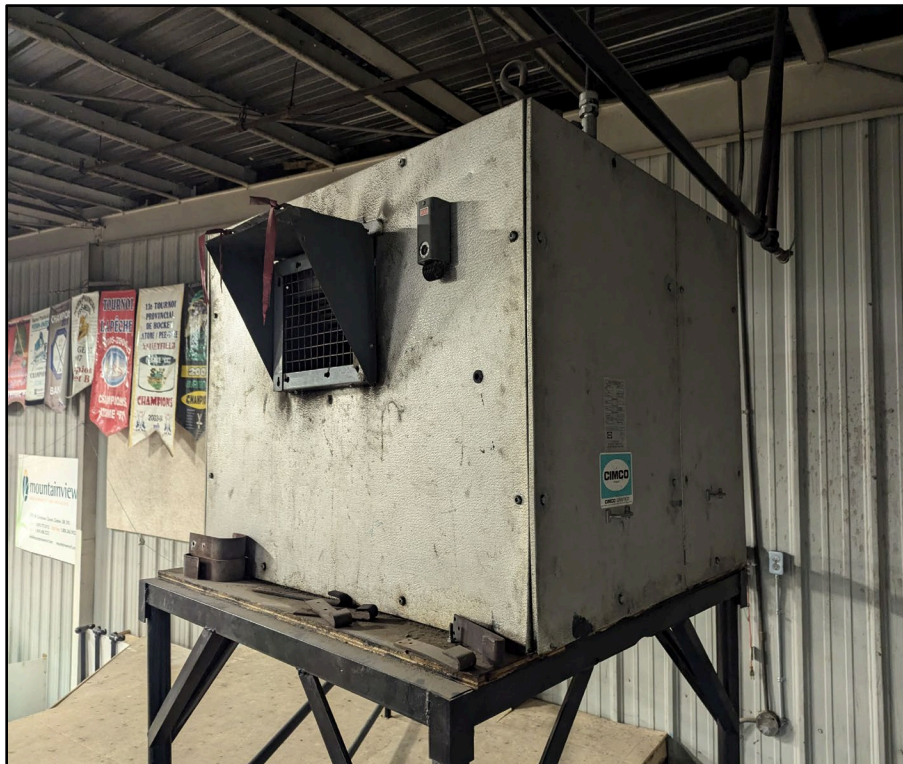
**Photo 10: Small Dehumidifier**

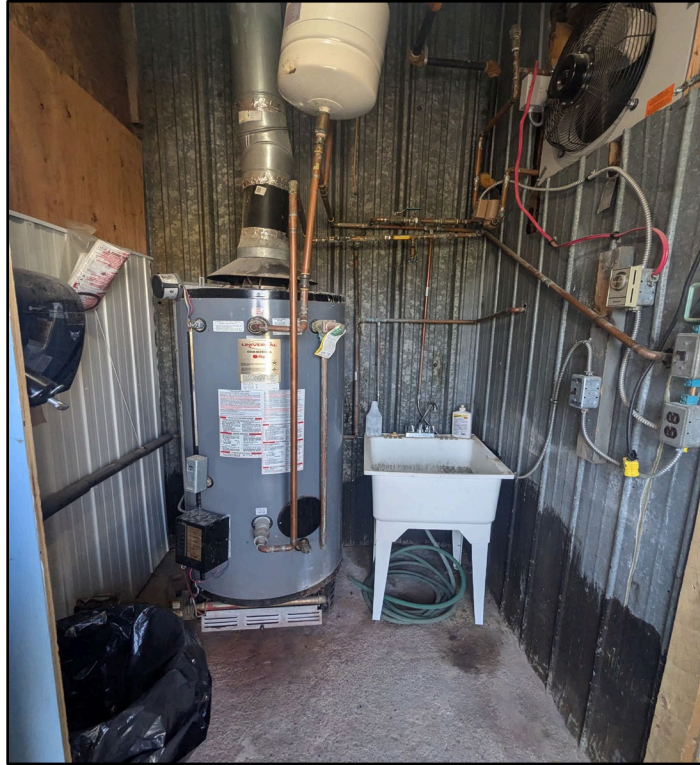
**Photo 13: DHW Heater (Zamboni Room)**

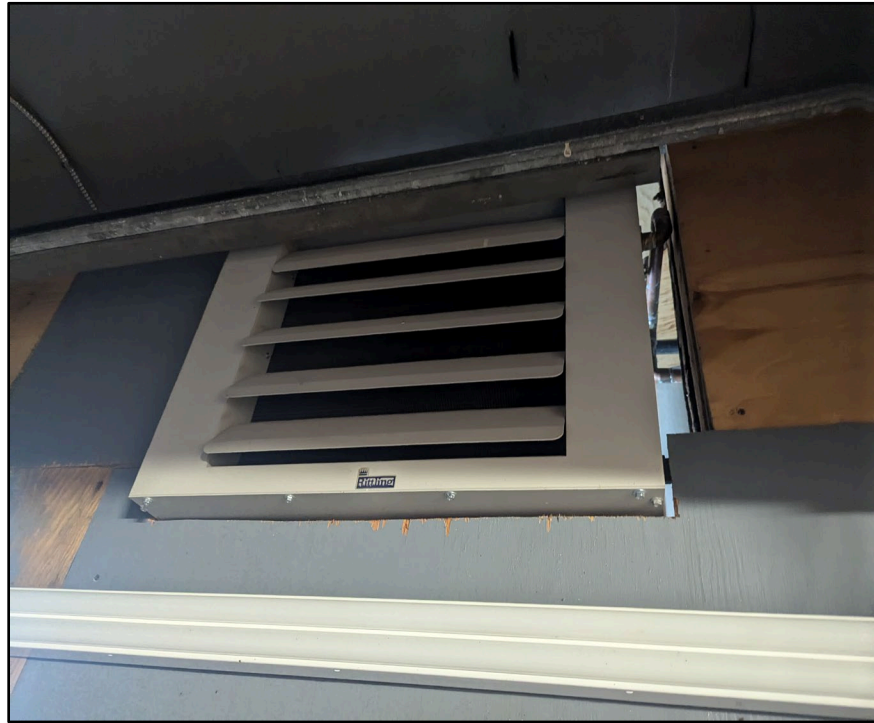
**Photo 21: Radiant Heater – Zamboni Room**

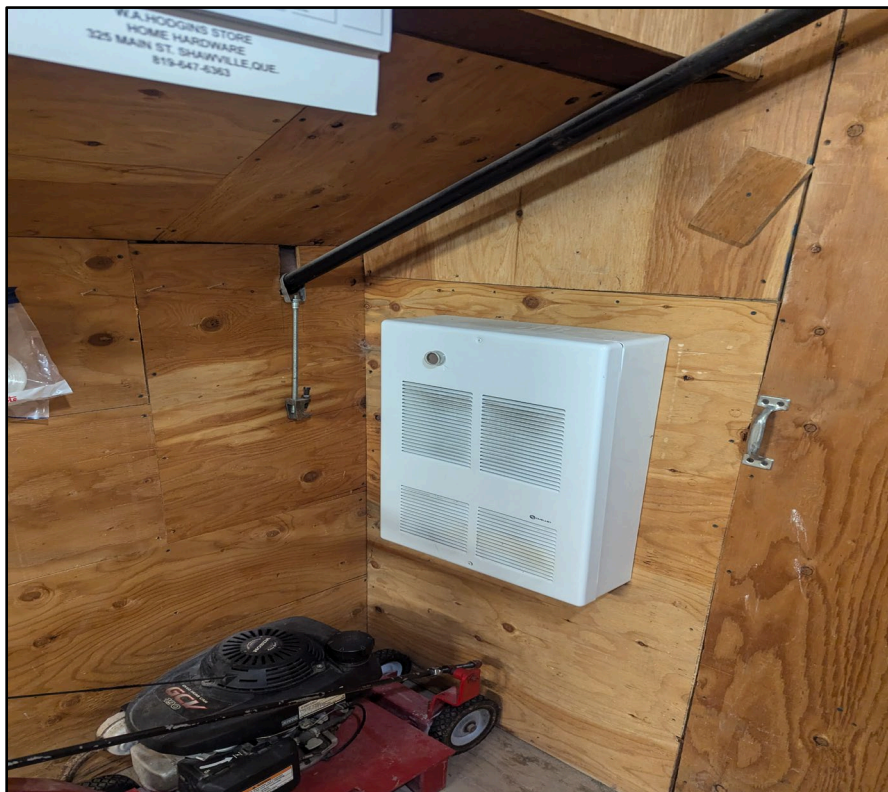
**Photo 22: Radiant Heater – Zamboni Room**

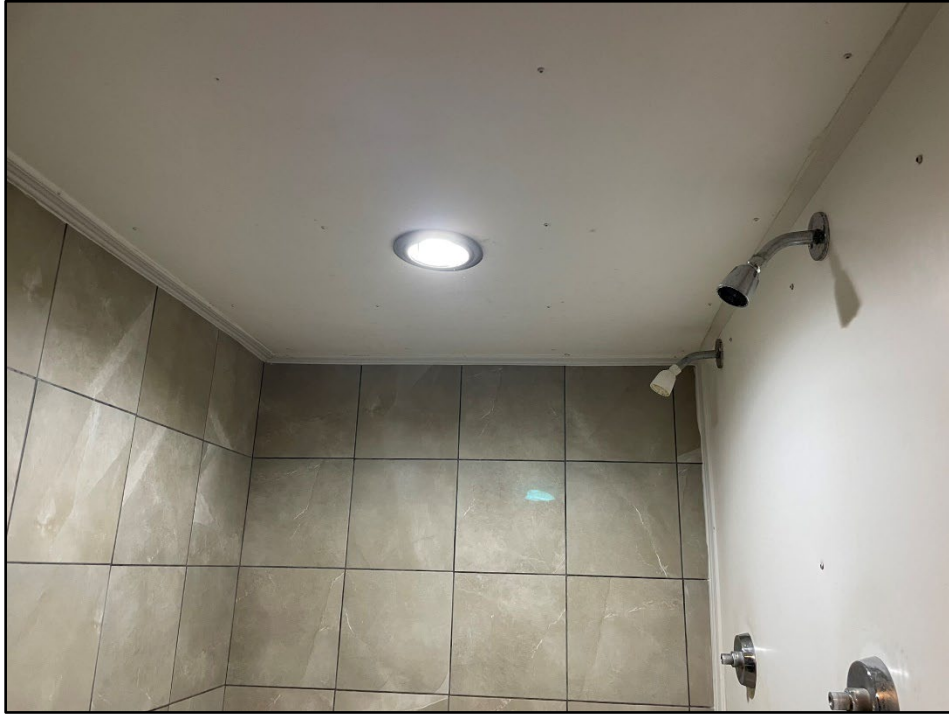
**Photo 15: Lighting Fixture in Shower**

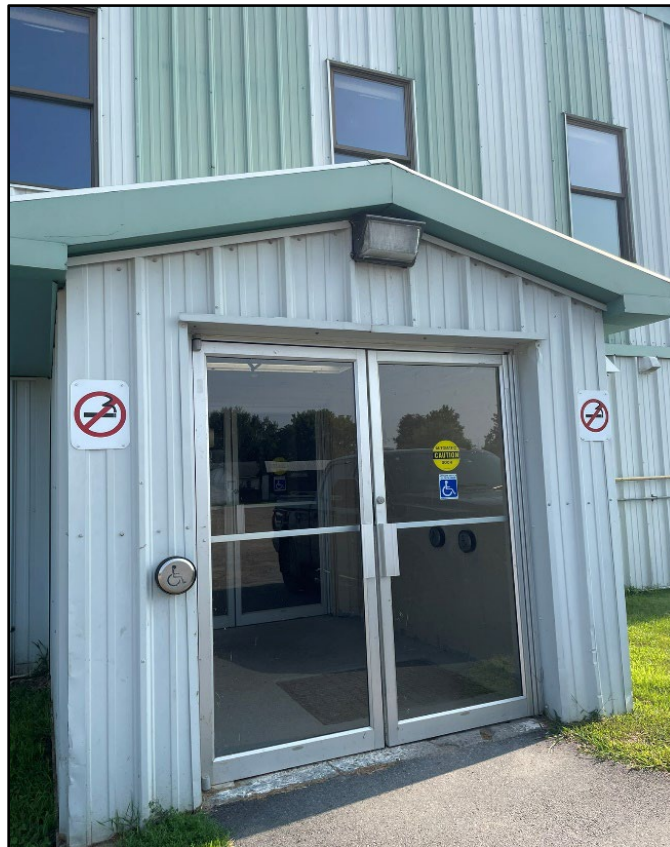
**Photo 16: Outdoor Wall Pack**
