**JLR No.: 32824-000.1**  
**Revision: 01**

**MUNICIPALITY OF SHAWVILLE**

# **Pre-Feasibility Report**

## **Shawville Arena, Municipality of Shawville**

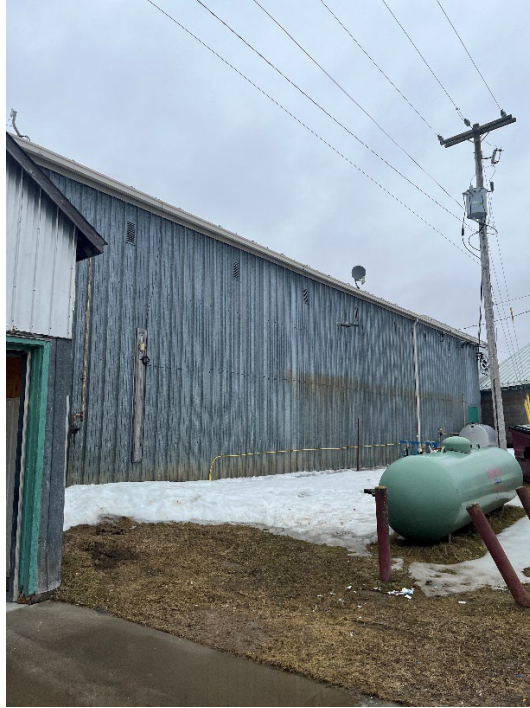
**Photo 4: West face of structure facing north.**

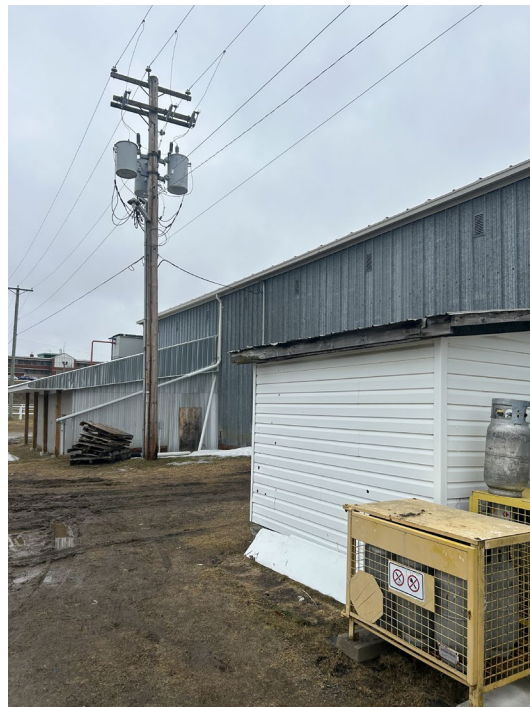
**Photo 5: Rear of arena.**

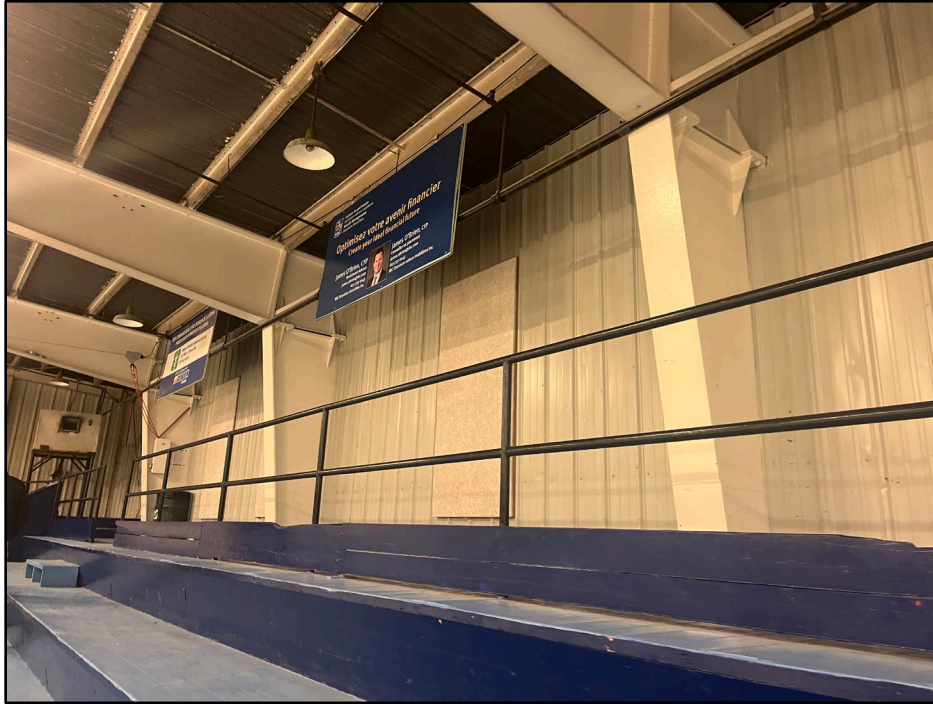
**Photo 8: Cross brace connection to steel roof beam at southeast end arena.**

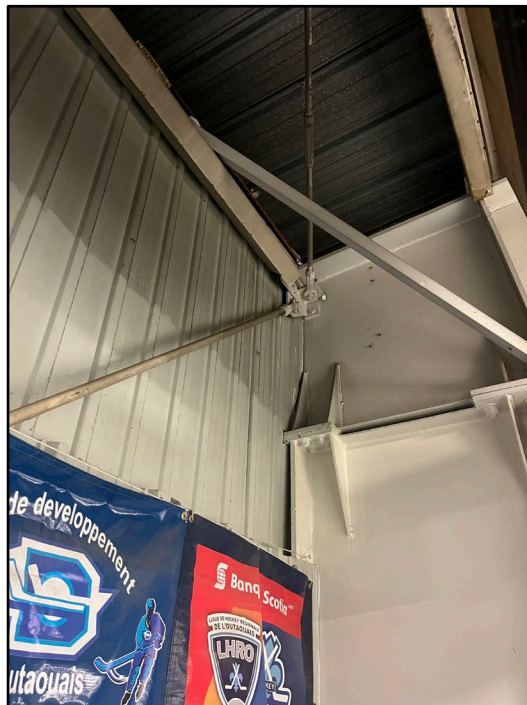
**Photo 9: Steel roof beam.**

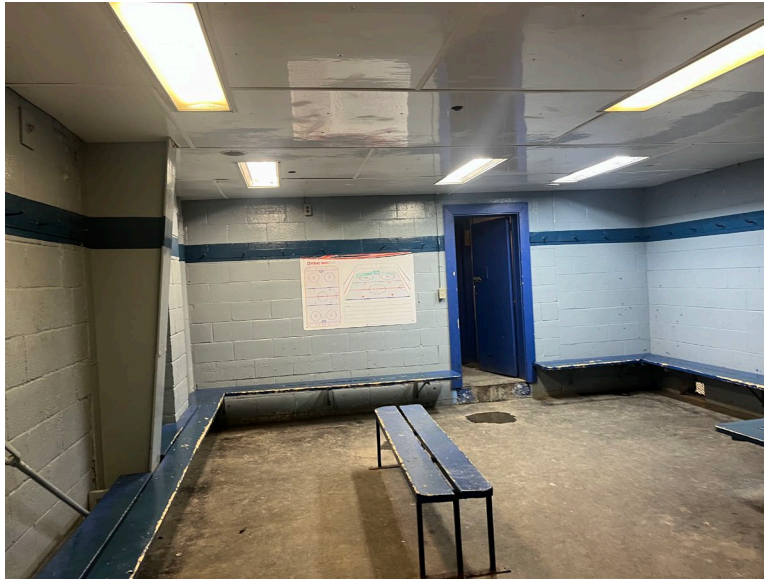
**Photo 18: Cross bracing at east side dressing room.**

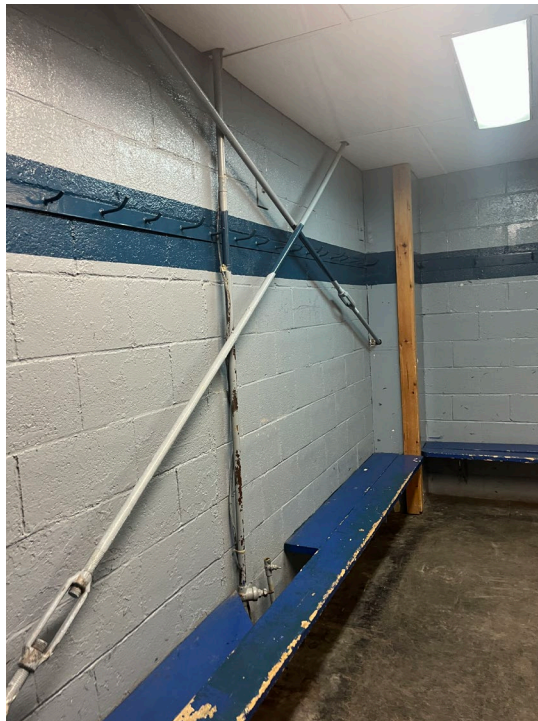
**Photo 19: Interior column at east side dressing room.**

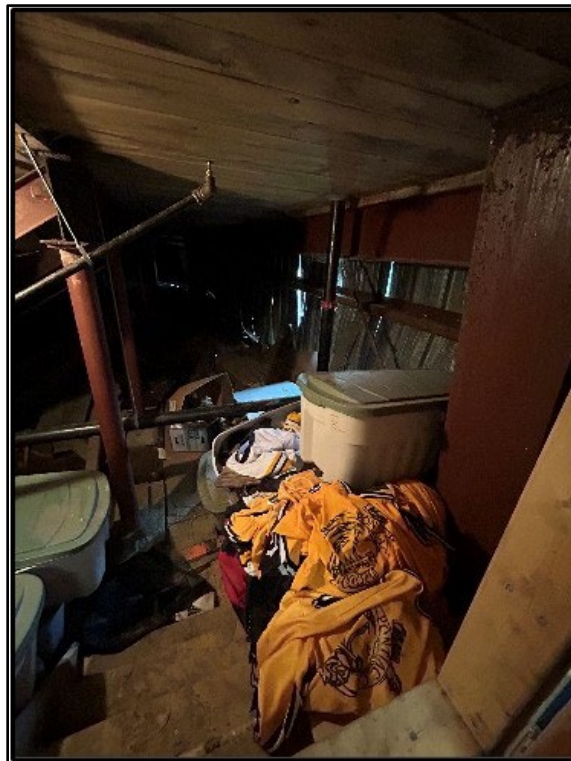
**Photo 10: Underneath wooden bleachers.**

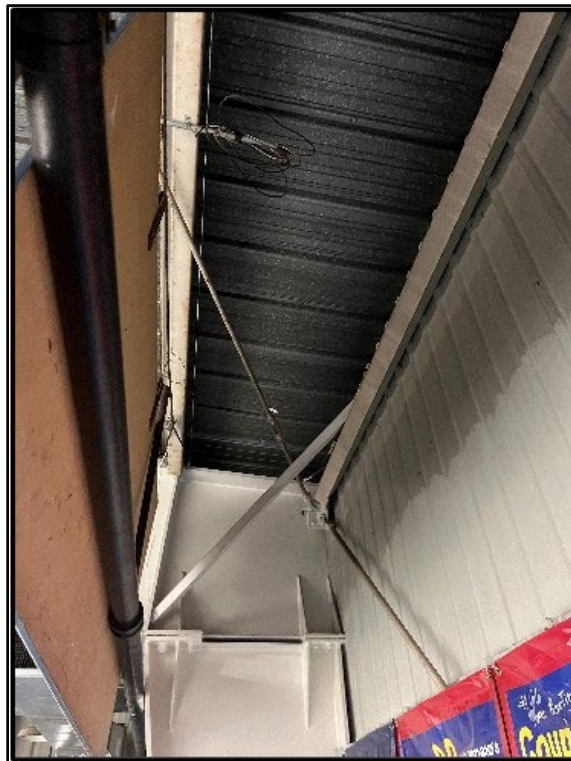
**Photo 16: Underside of roof panels.**

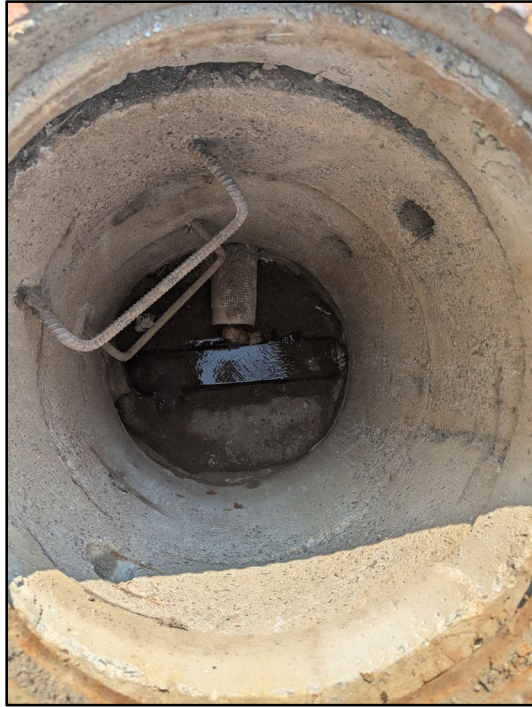
**Photo 1: Front entrance manhole interior (closest to arena).**

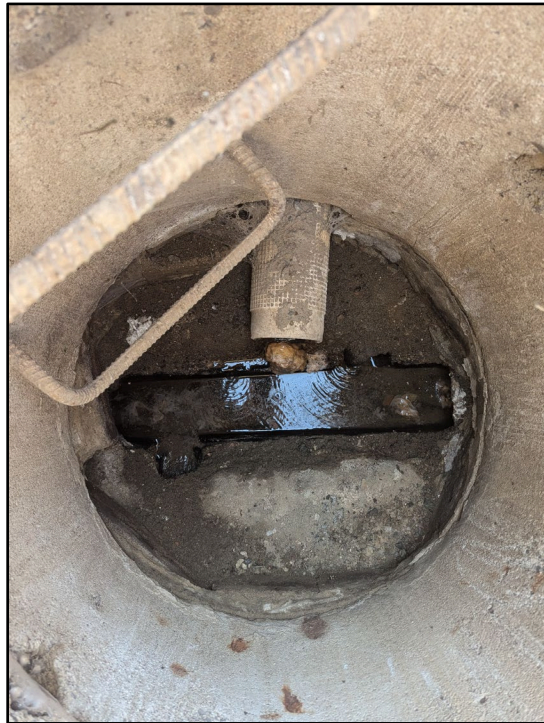
**Photo 2: Front entrance parking lot manhole interior.**

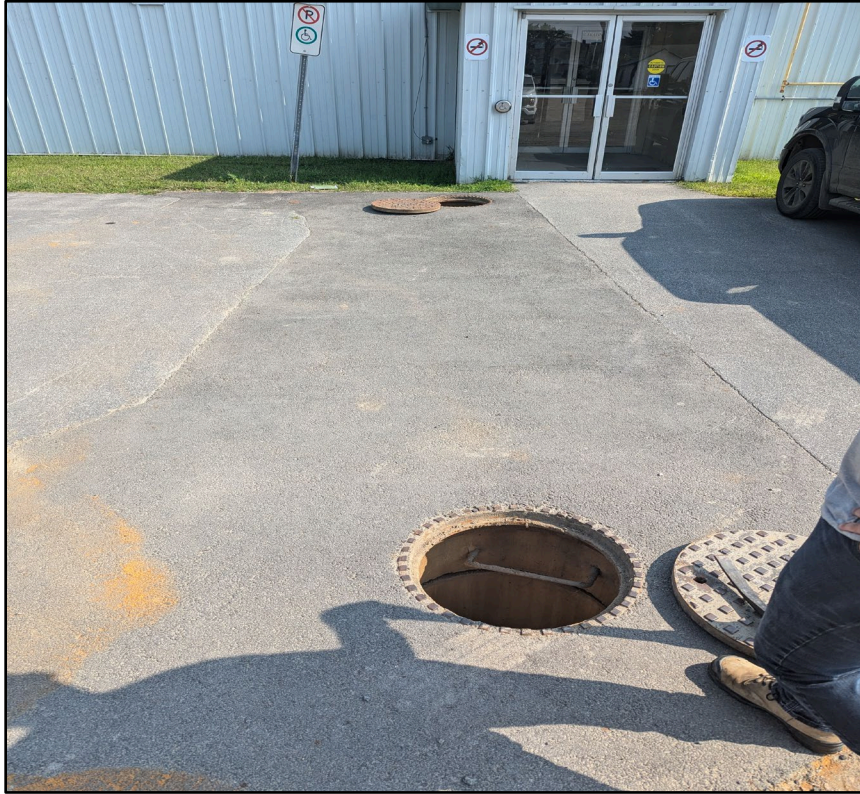
**Photo 3: Wide shot of front entrance manholes.**

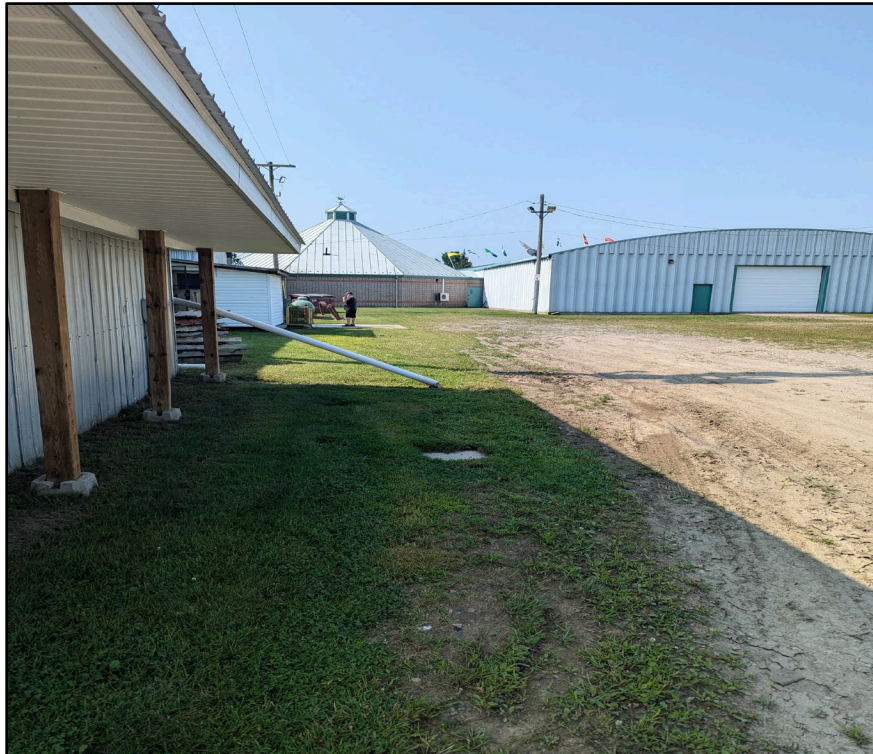
**Photo 4: Manhole at west side of arena.**

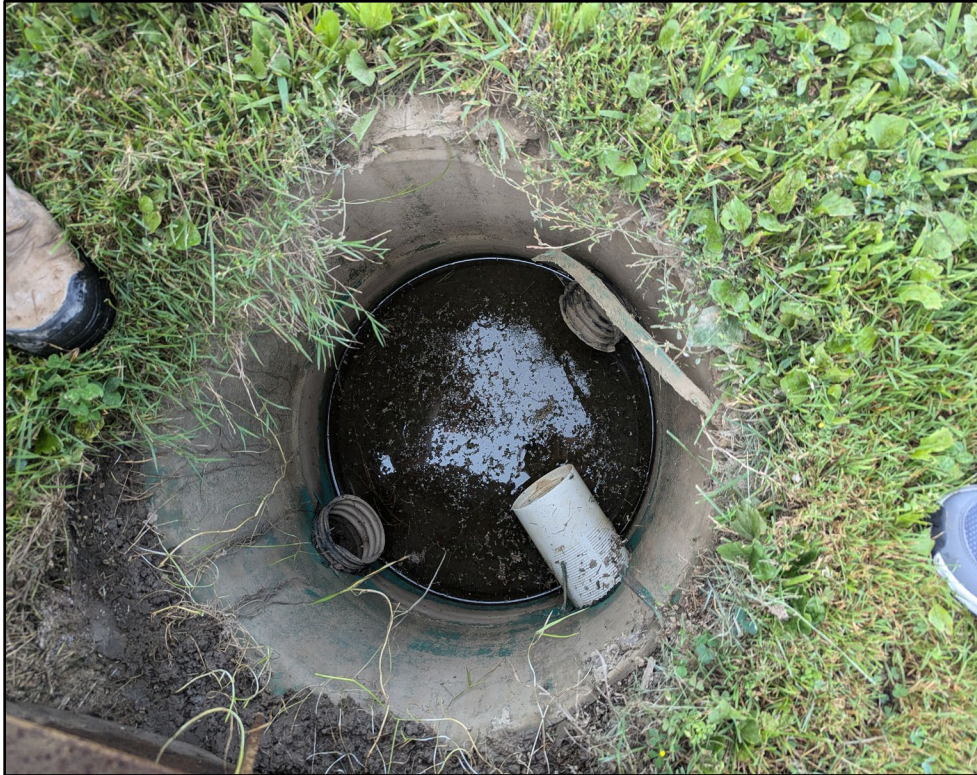
**Photo 5: Manhole at west side of structure.**

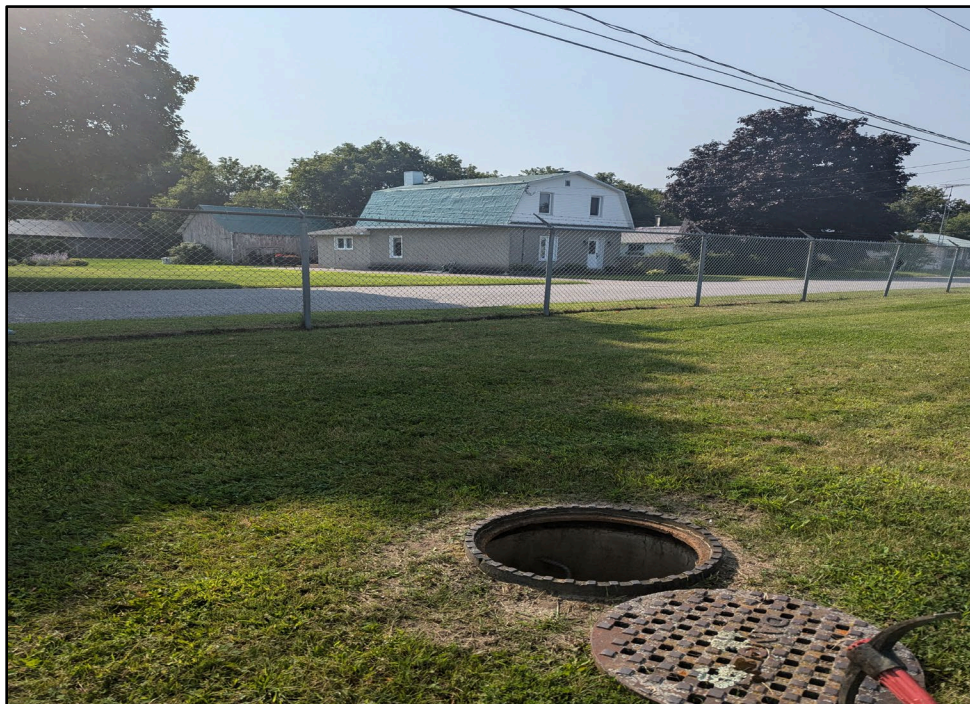
**Photo 6: East field manhole.**

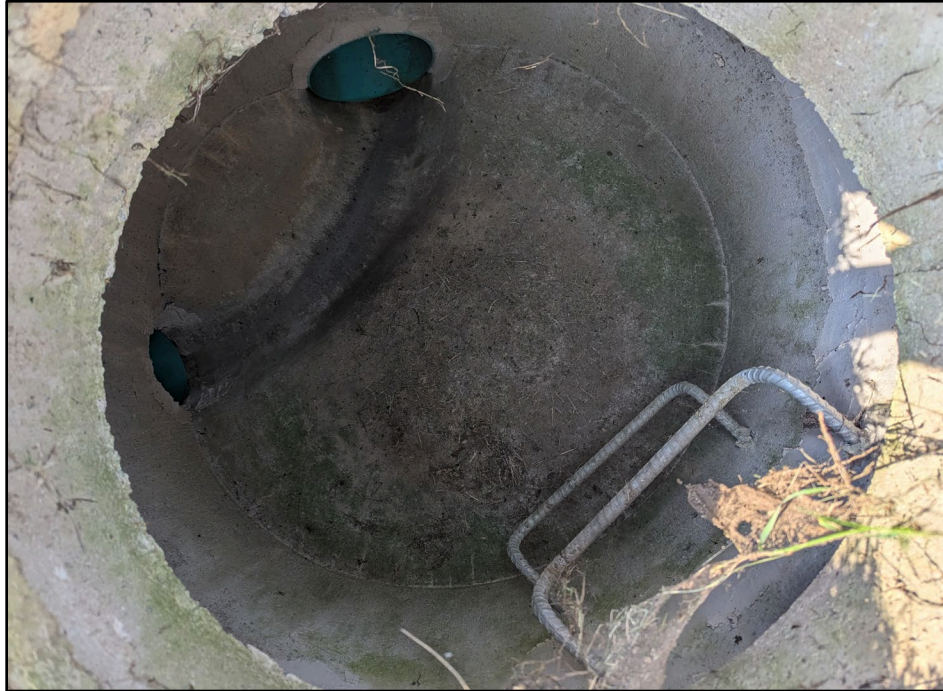
**Photo 7: East field manhole interior.**

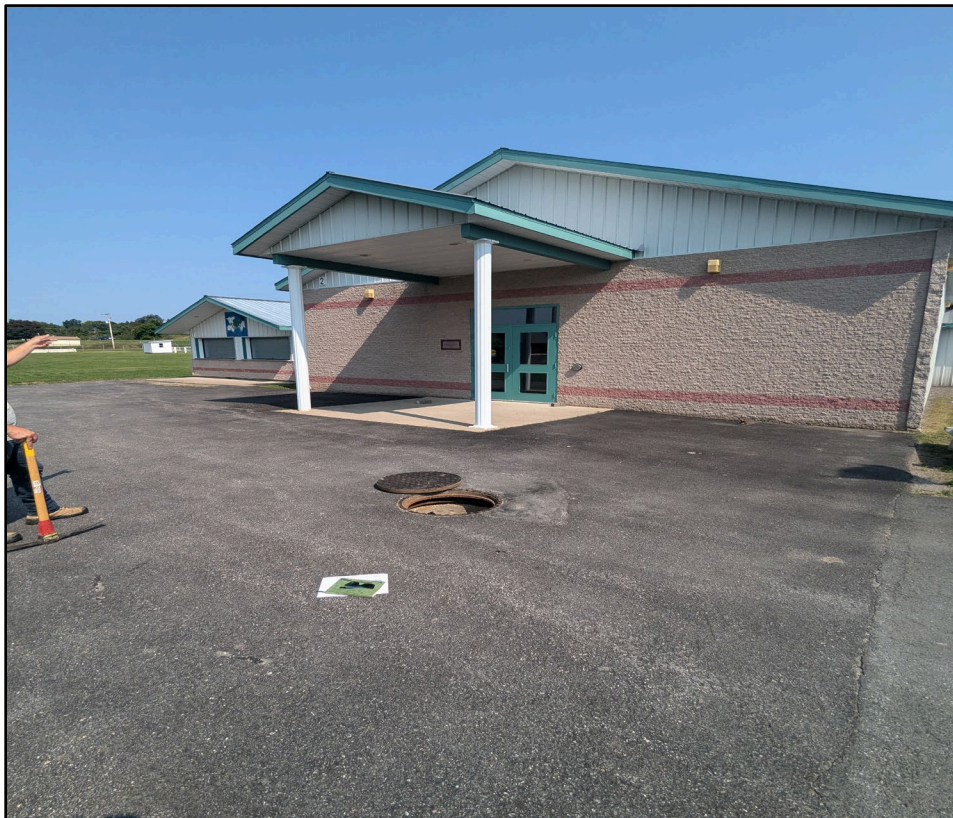
**Photo 8: Manhole west of arena.**

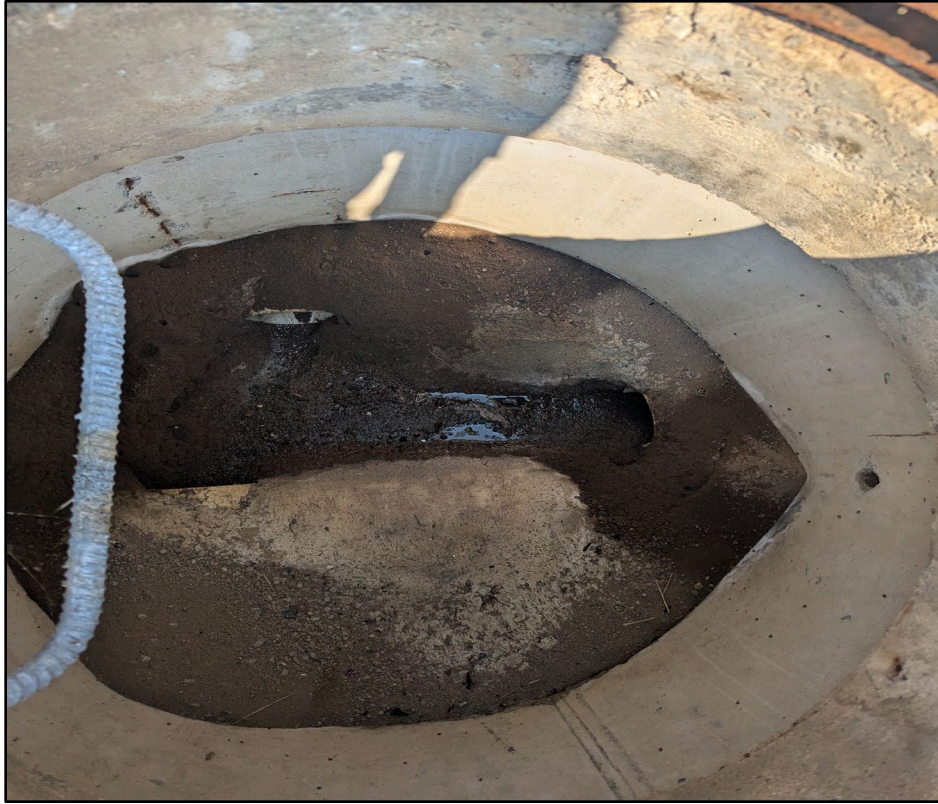
**Photo 9: Manhole west of arena.**

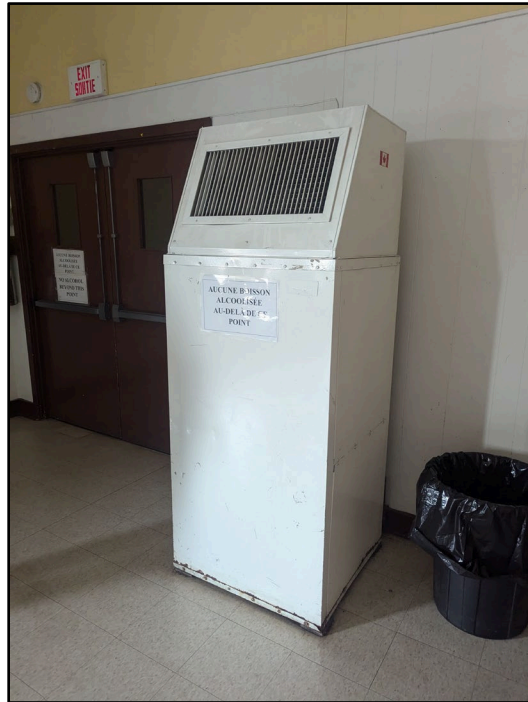
**Photo 1: AC Unit 1**

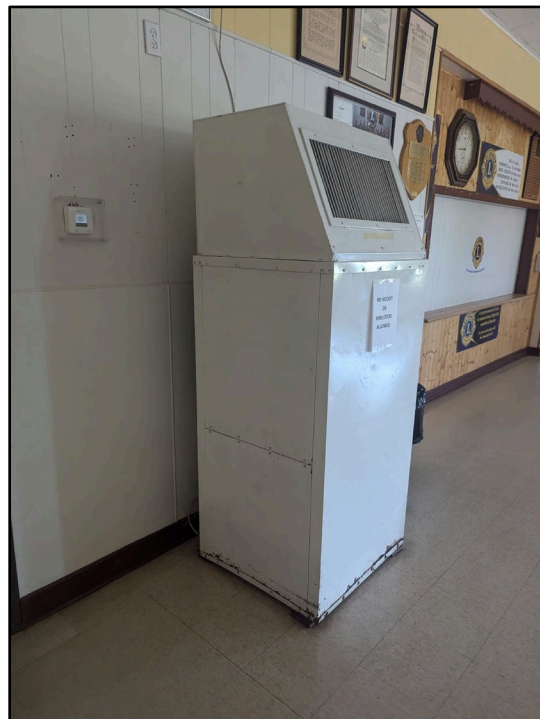
**Photo 2: AC Unit 2**

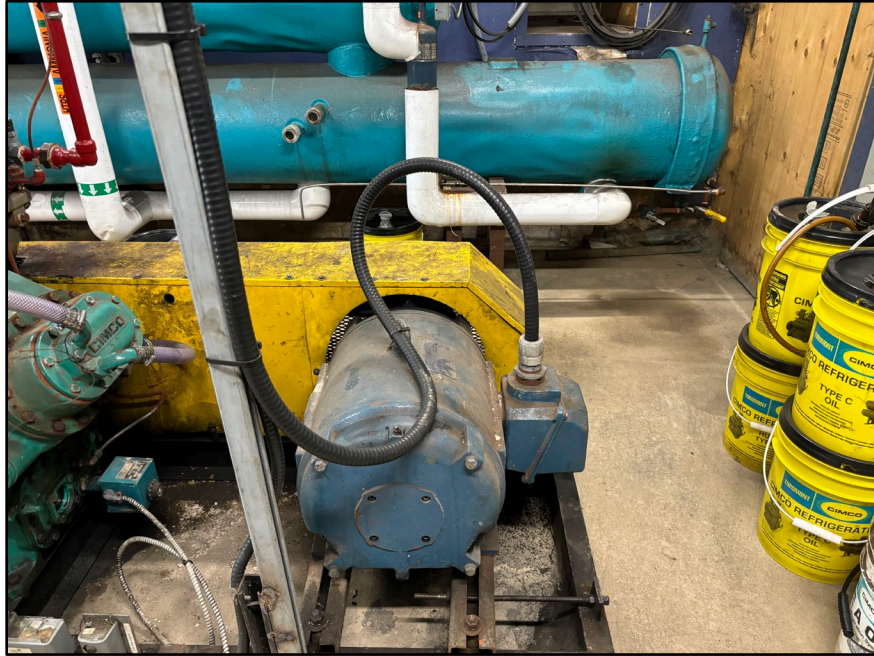
**Photo 3: AO Smith Motor**

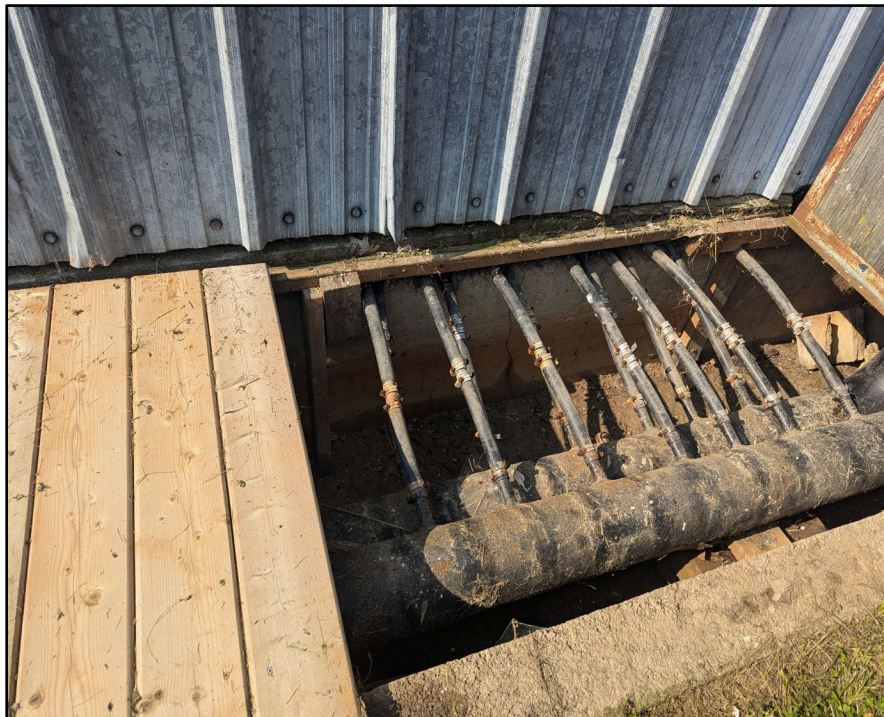
**Photo 4: Brine or Glycol Circulation Pipes**

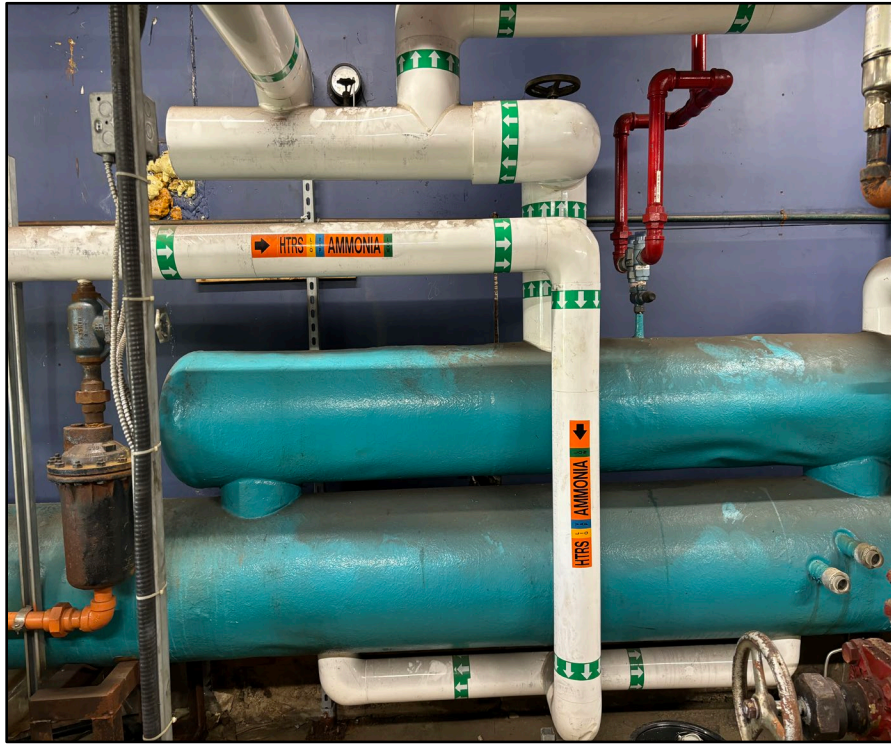
**Photo 5: Chiller**

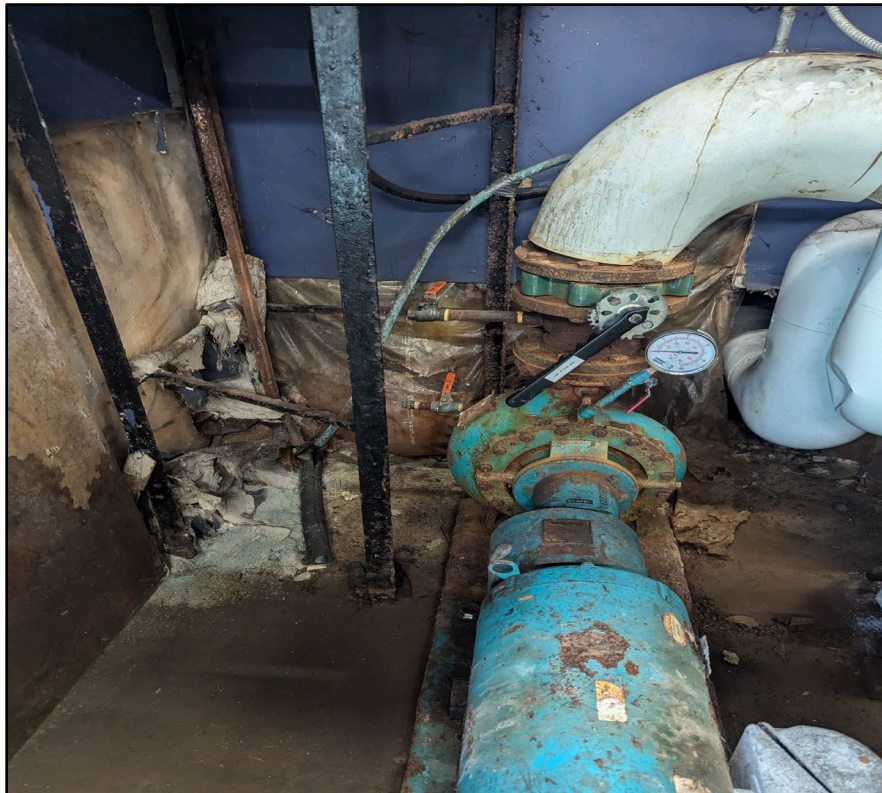
**Photo 6: Glycol Circulation Pump**

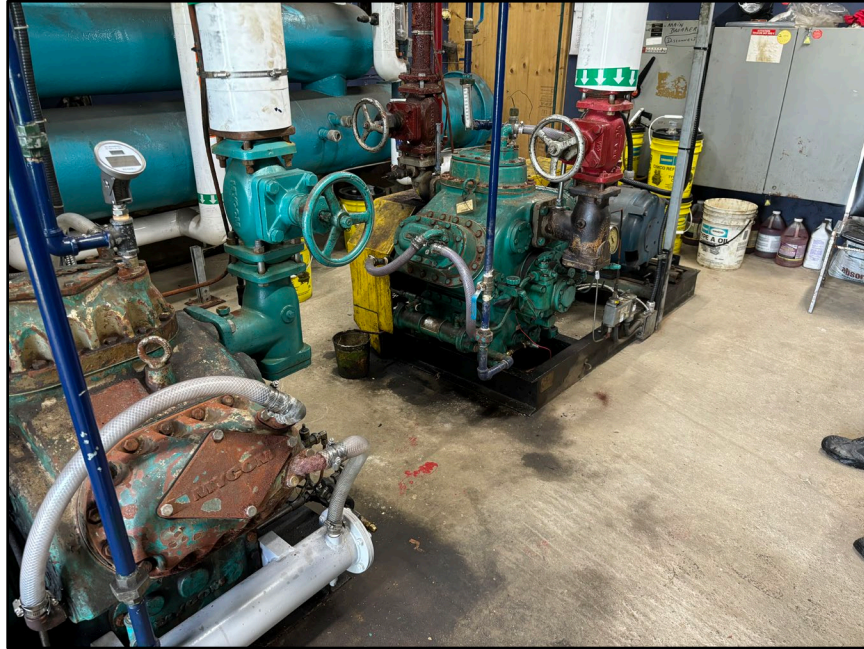
**Photo 7: Compressor Units**

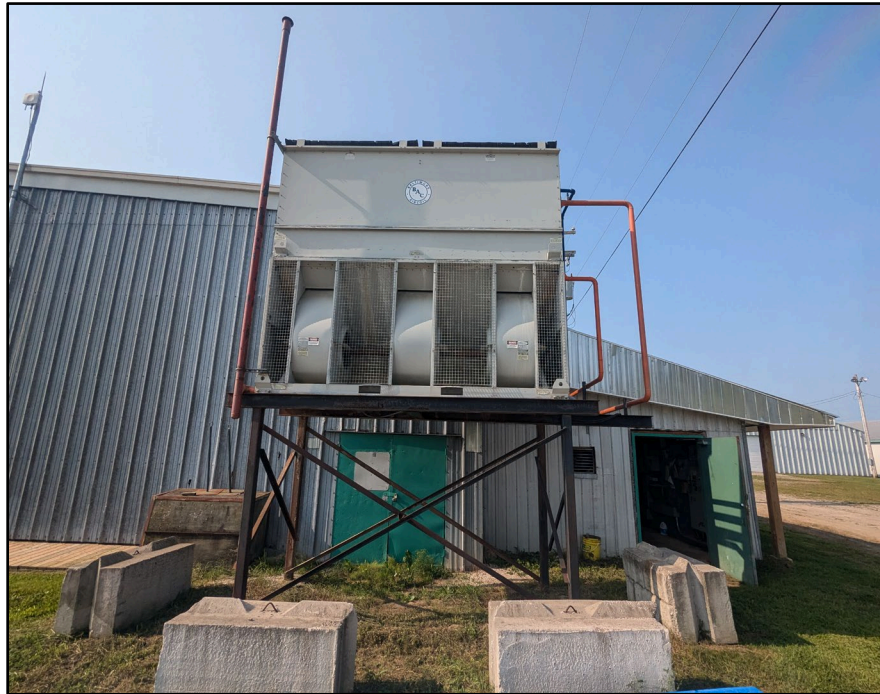
**Photo 8: Cooling Tower**

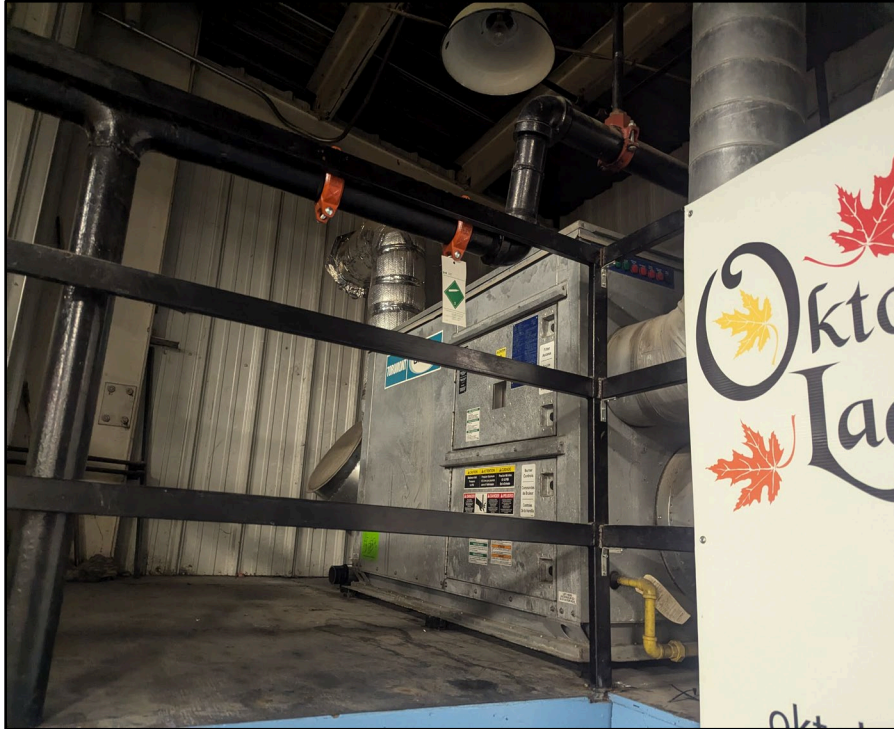
**Photo 9: Large Dehumidifier**

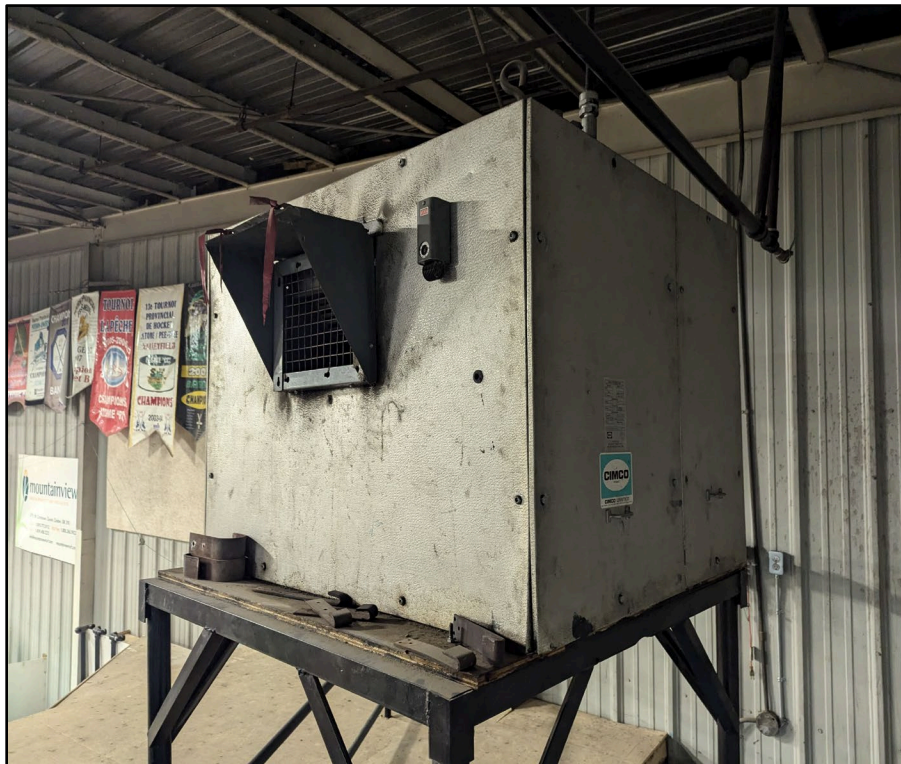
**Photo 10: Small Dehumidifier**

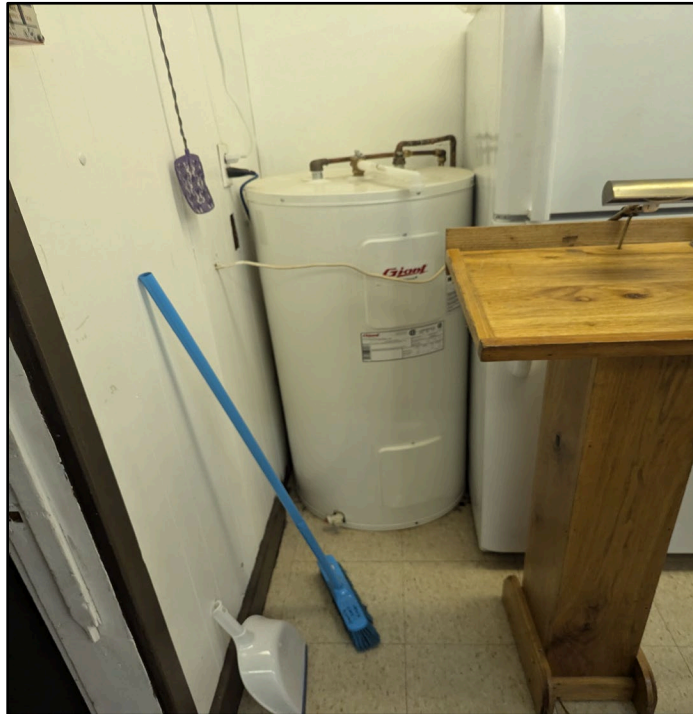
**Photo 11: DHW Heater (Kitchen)**

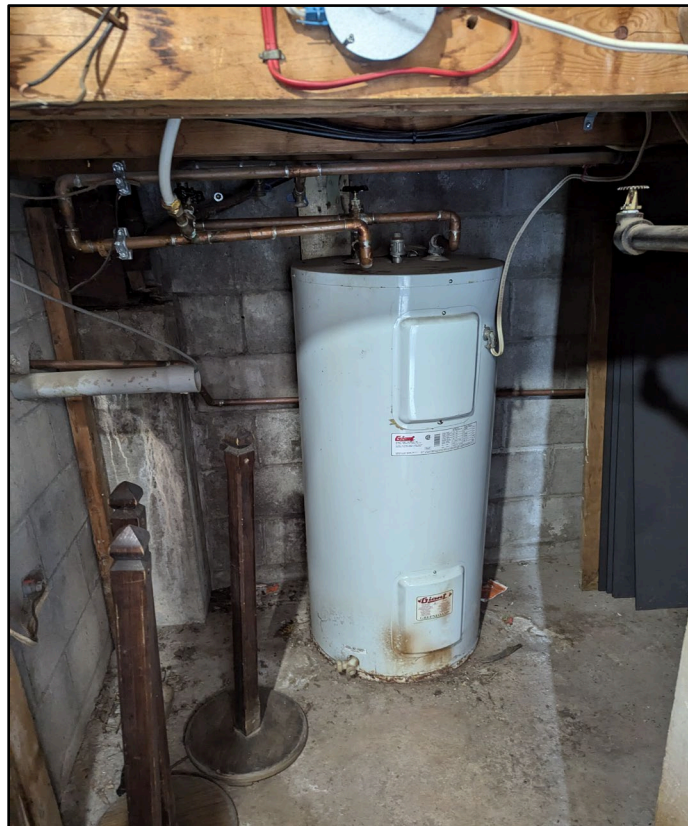
**Photo 12: DHW Heater (Stairs)**

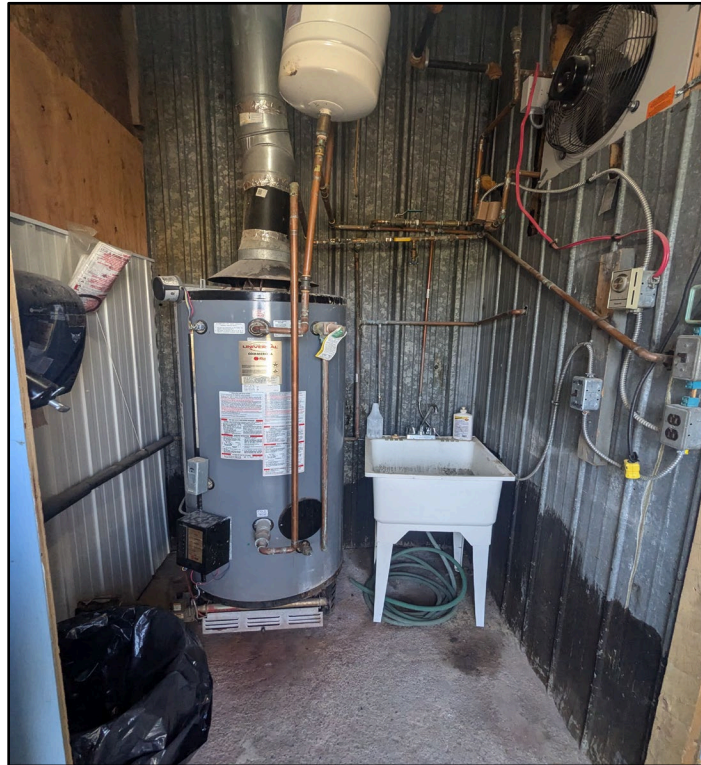
**Photo 13: DHW Heater (Zamboni Room)**

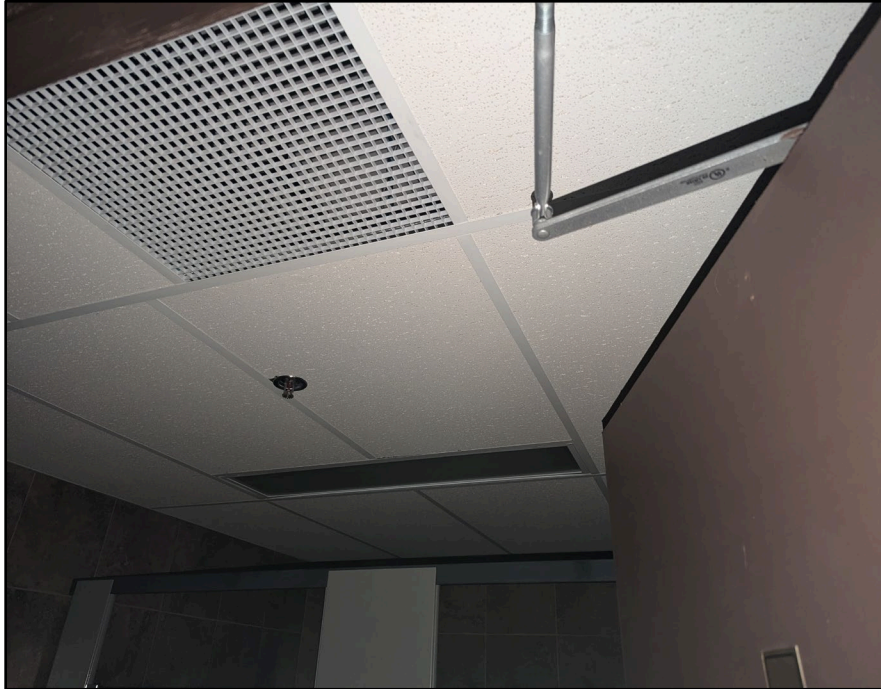
**Photo 15: Exhaust Fan**

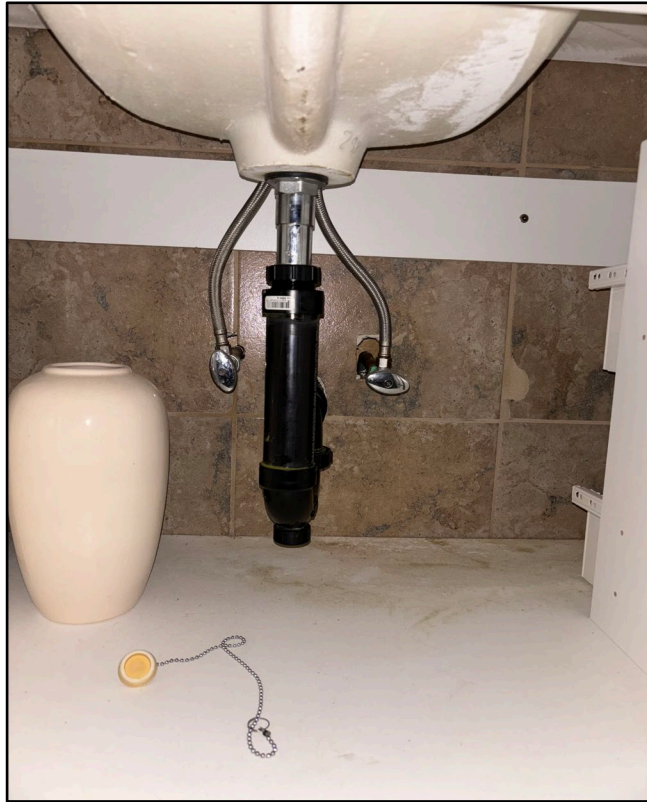
**Photo 17: Plumbing Fixtures**

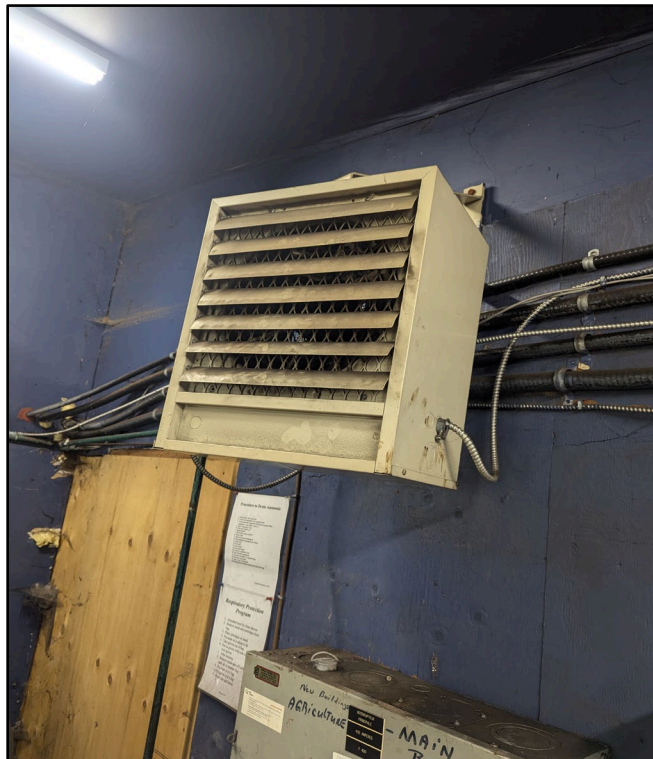
**Photo 18: Radiant Heater - Ammonia**

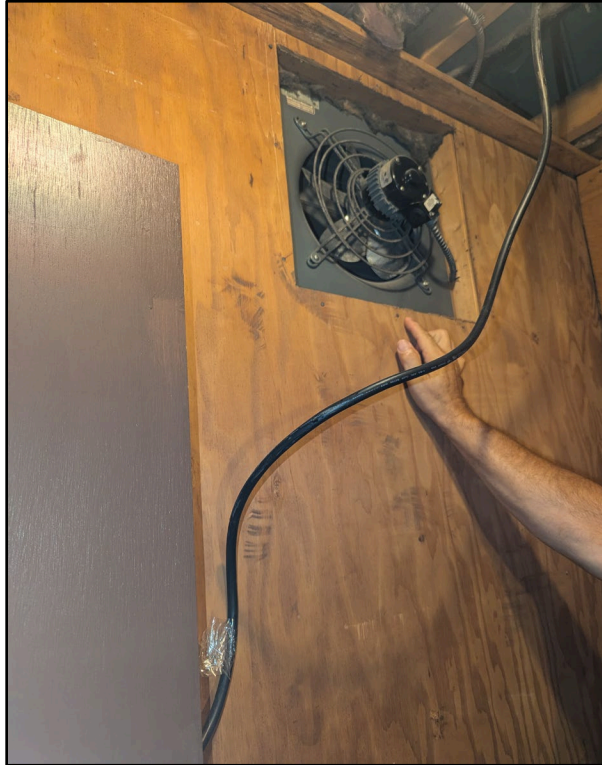
**Photo 19: Radiant Heater - Furnace**

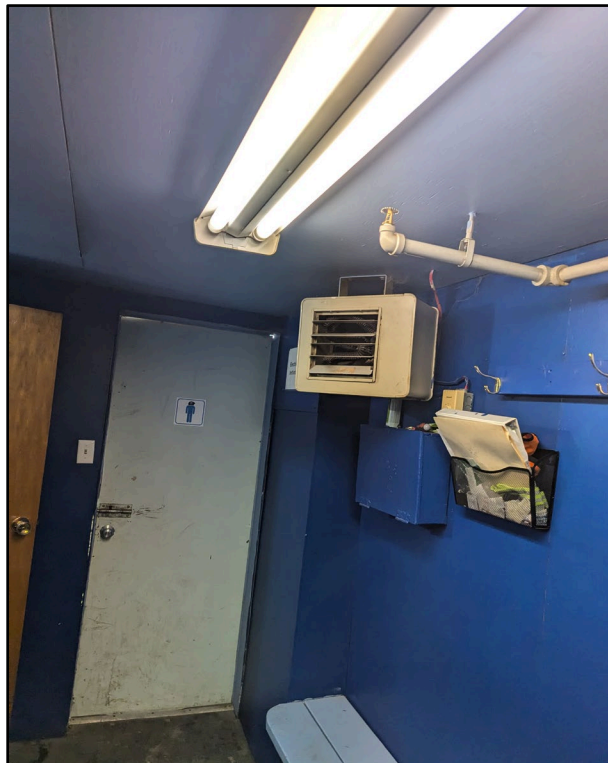
**Photo 20: Radiant Heater – Referee Room**

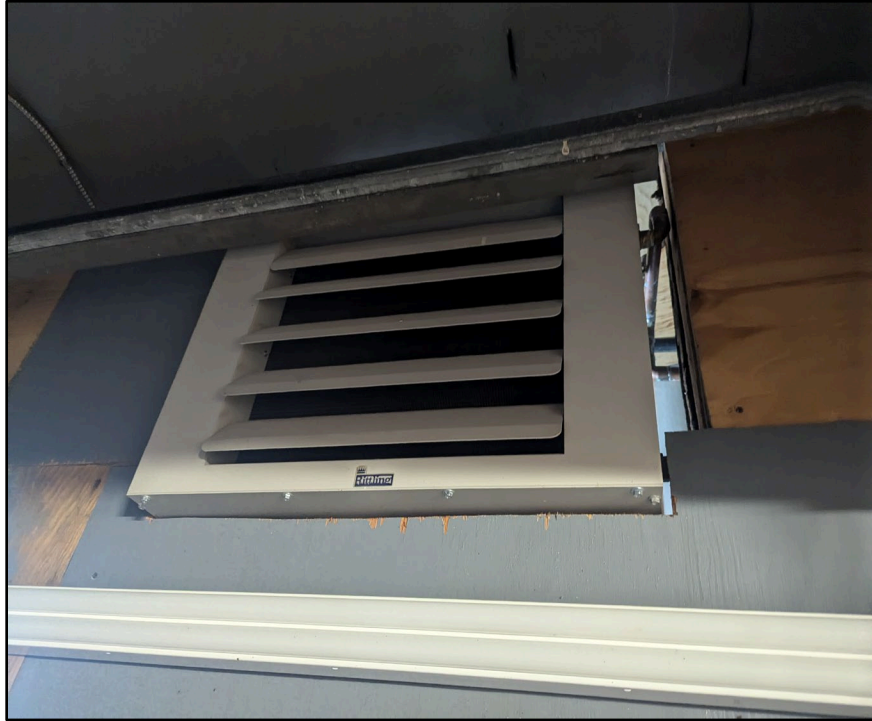
**Photo 21: Radiant Heater – Zamboni Room**

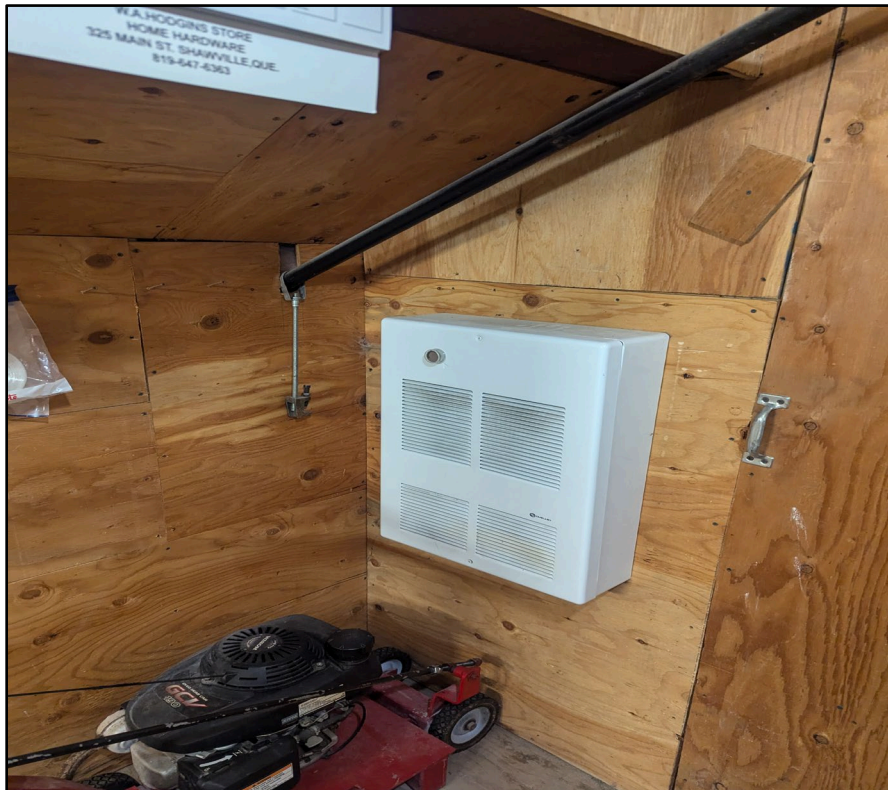
**Photo 22: Radiant Heater – Zamboni Room**

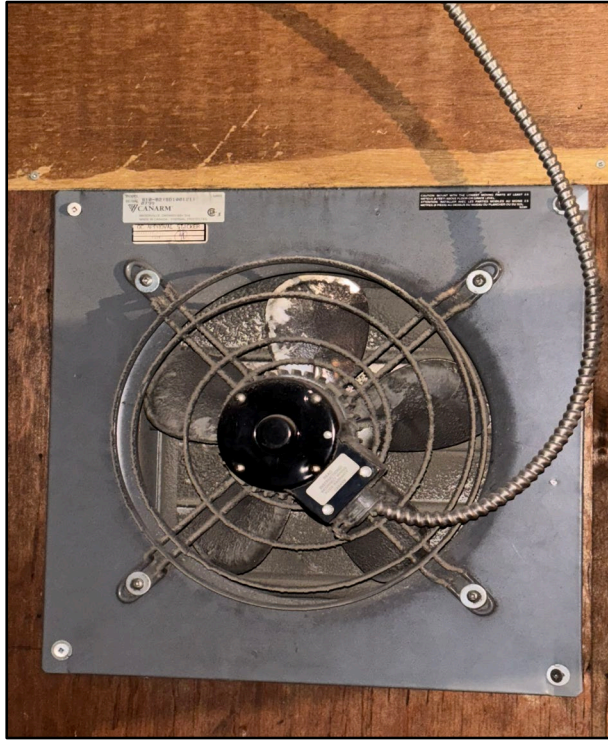
**Photo 23: Radiant Heater – Furnace 1**

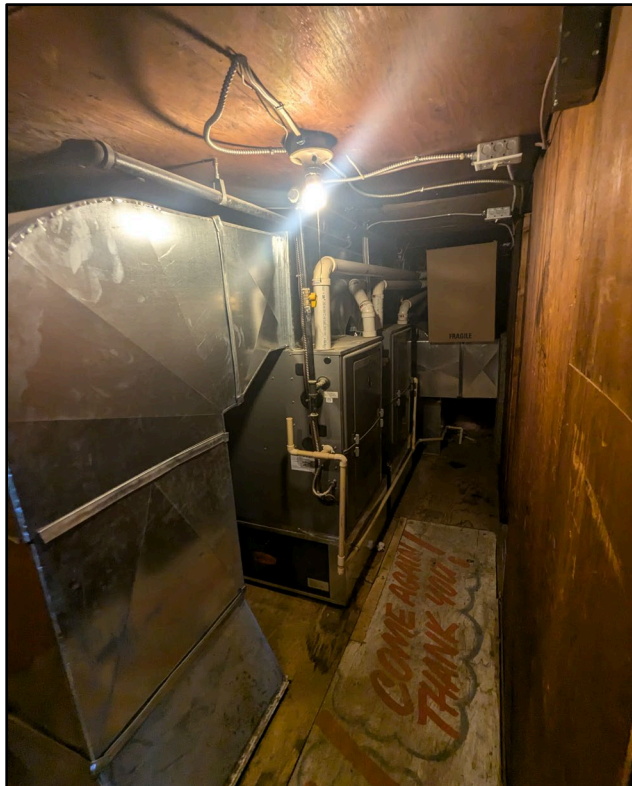
**Photo 24: Radiant Heater – Furnace 2**

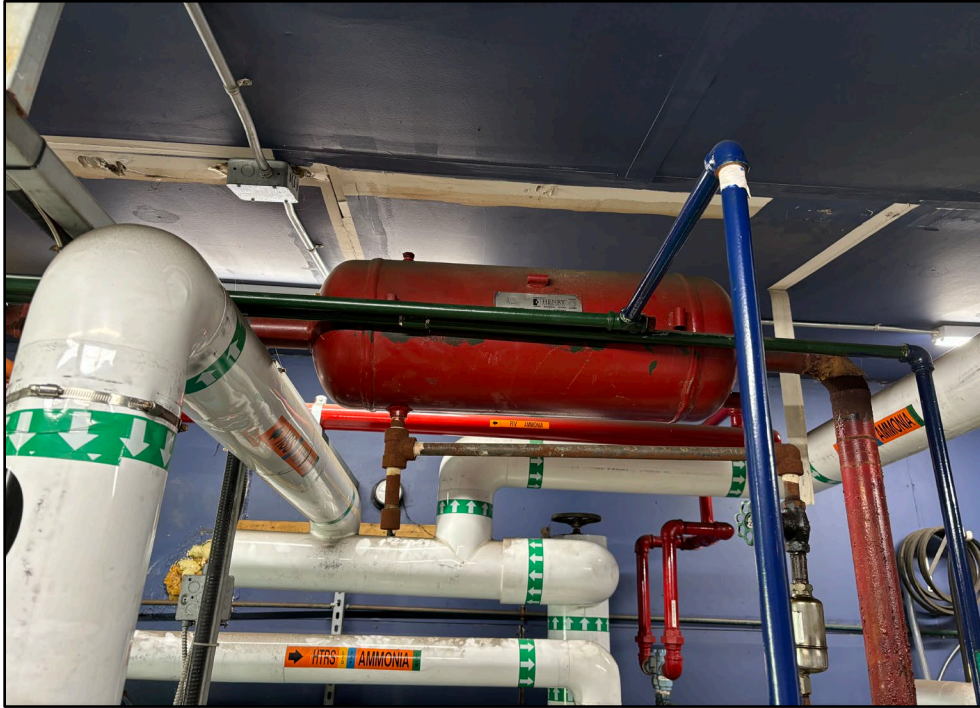
**Photo 25: Separator 1**

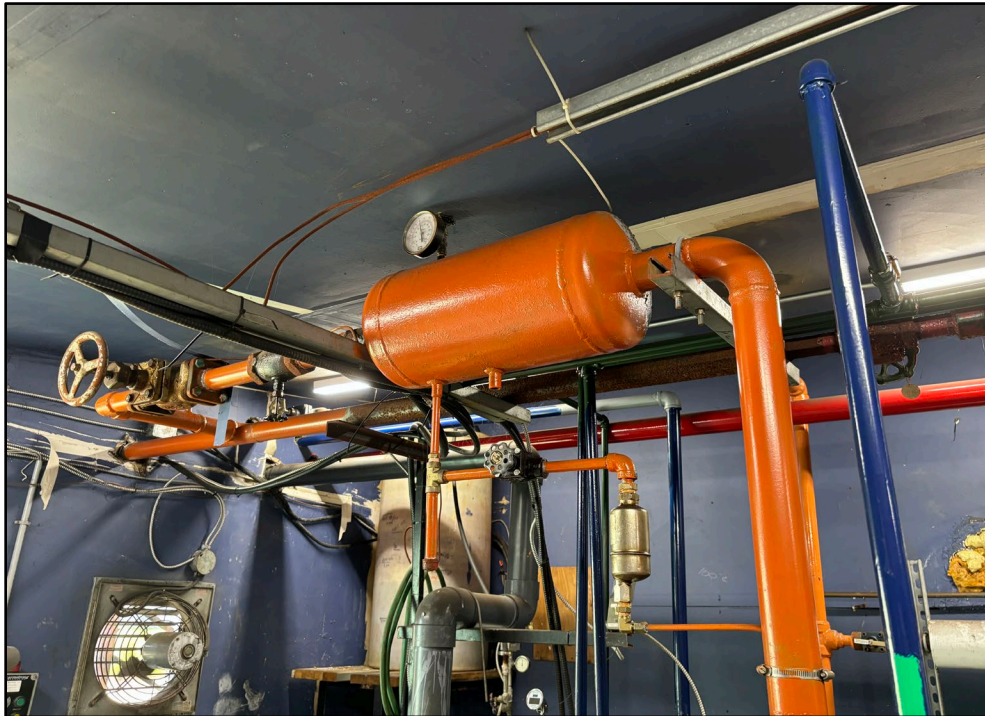
**Photo 26: Separator 2**
