**JLR No.: 32824-000.1**  
**Revision: 01**

**MUNICIPALITY OF SHAWVILLE**

# **Pre-Feasibility Report**

## **Shawville Arena, Municipality of Shawville**

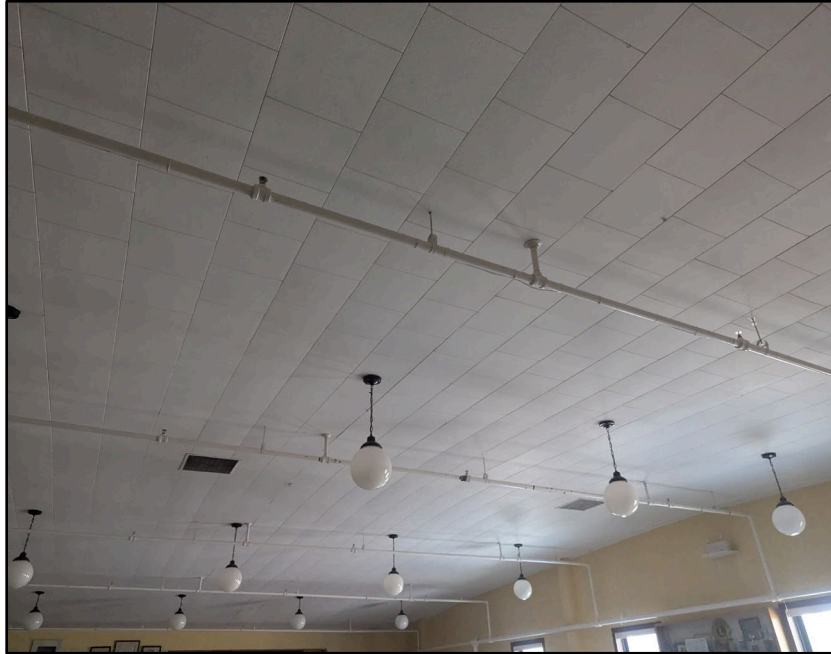
**Photo 27: Sprinkler System**

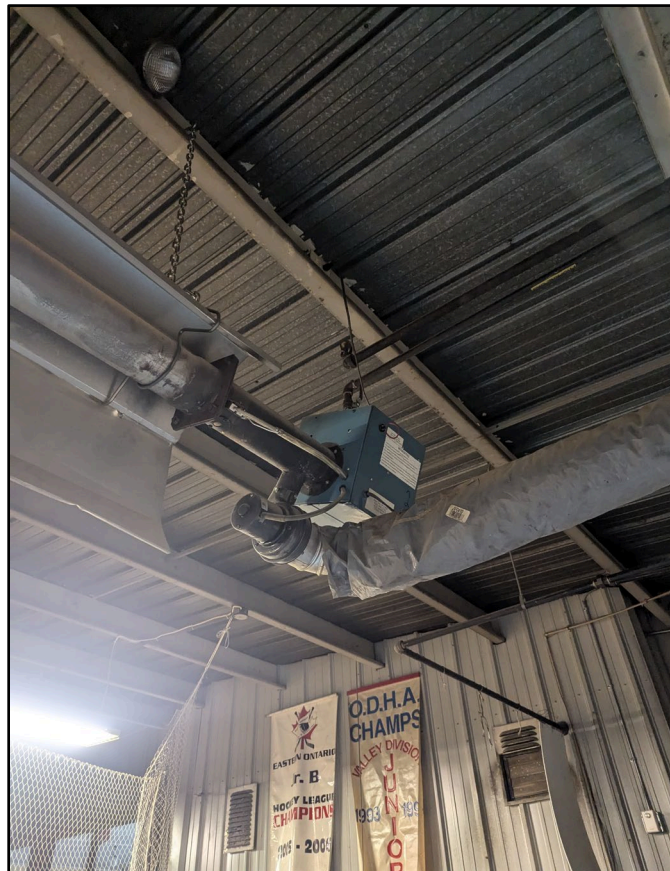
**Photo 28: Tube Radiant Heater**

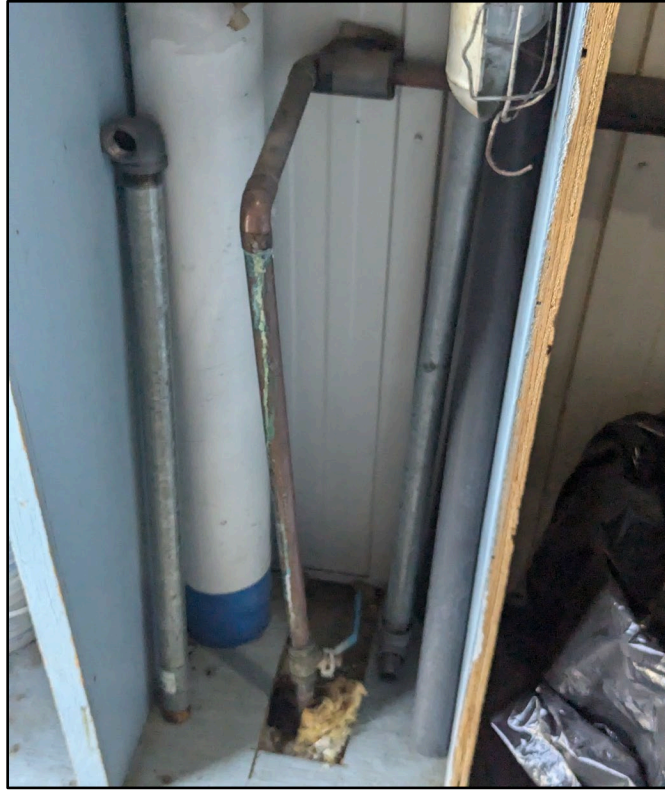
**Photo 29: Zamboni Room Water Entry**

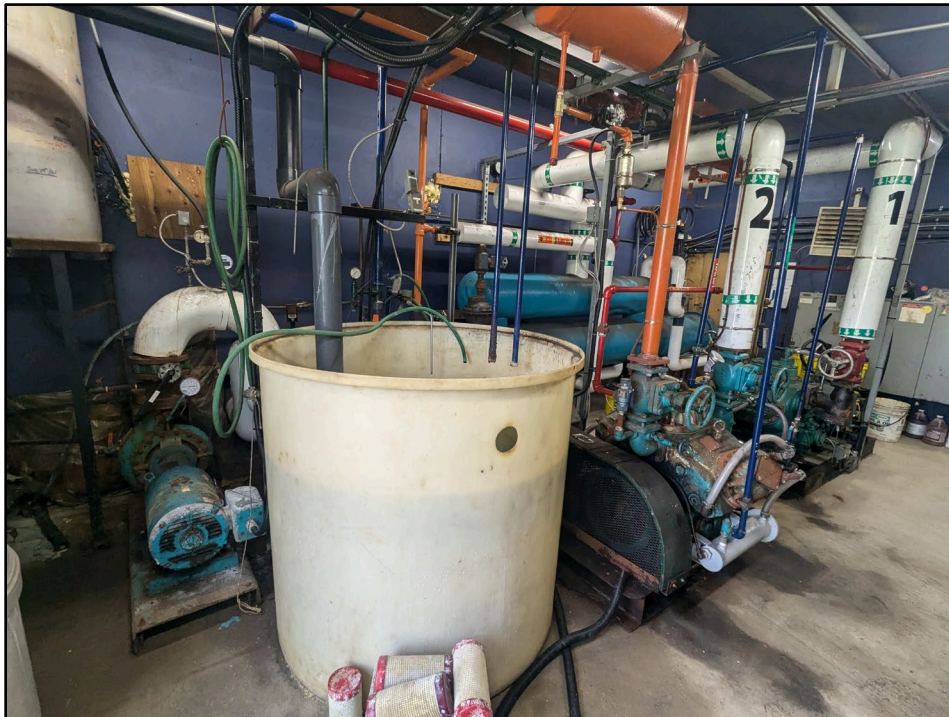
**Photo 30: Water Tank**

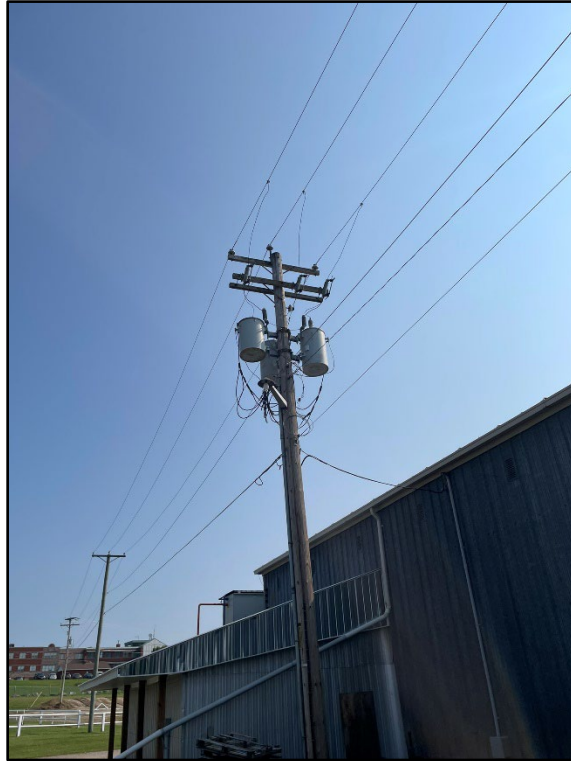
**Photo 1: Pole Mounted Transformers**

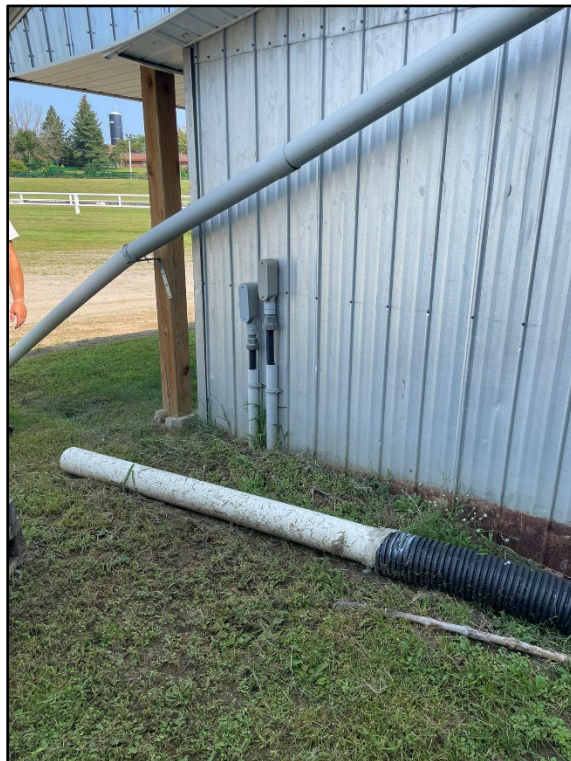
**Photo 2: Service Entrance**

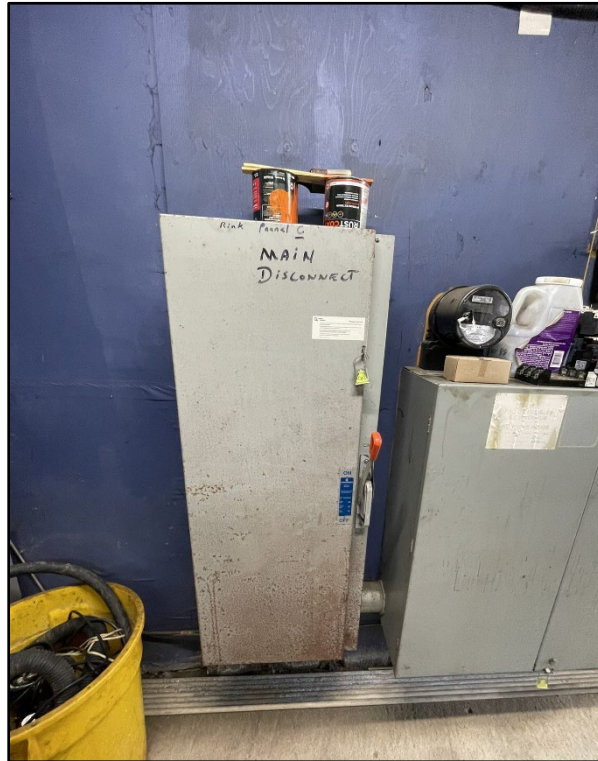
**Photo 3: 400A, 600V Disconnect**

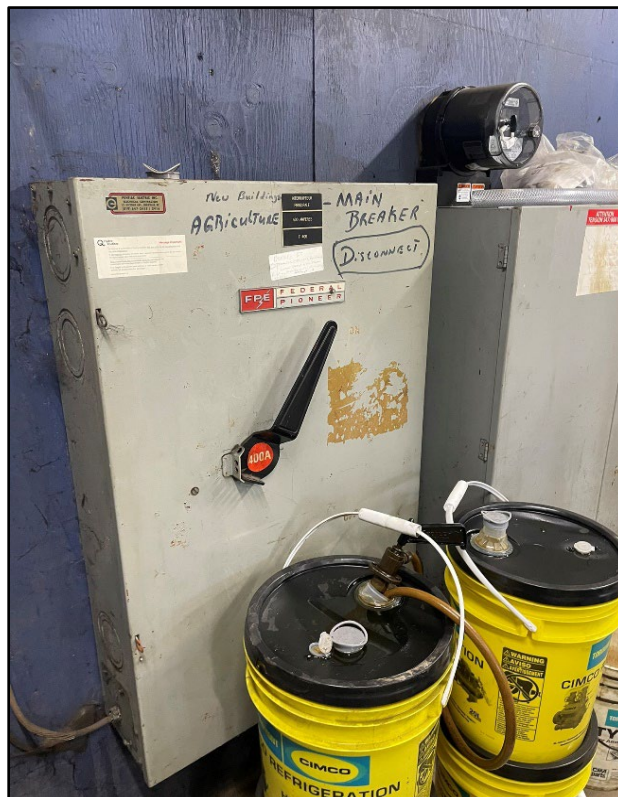
**Photo 4: 400A, 600V Disconnect**

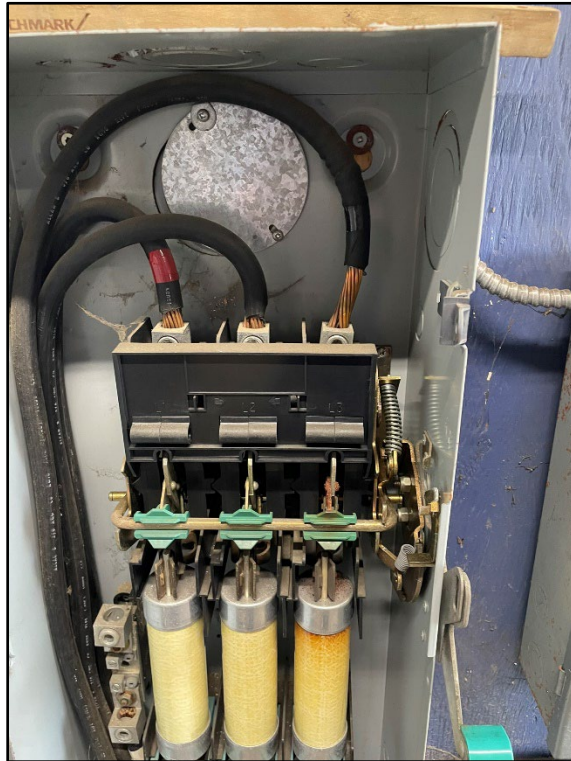
**Photo 9: Wire Termination Issues**

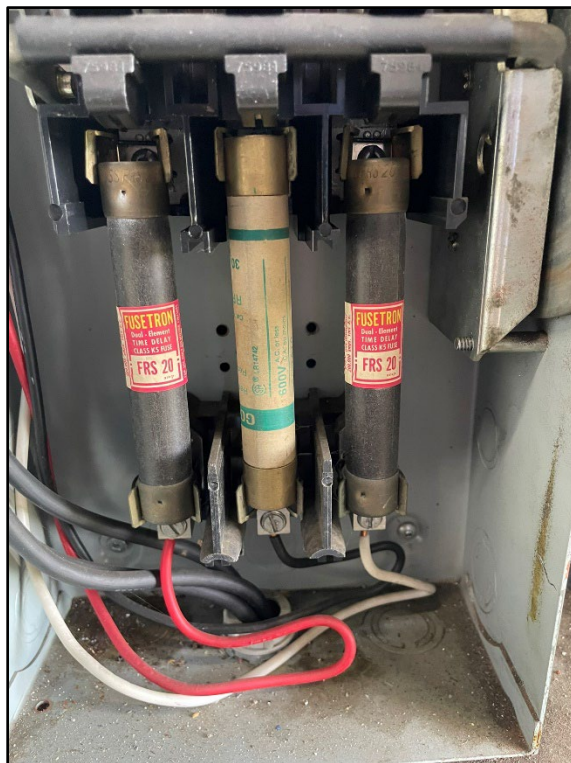
**Photo 10: Non-Matching Fuses**

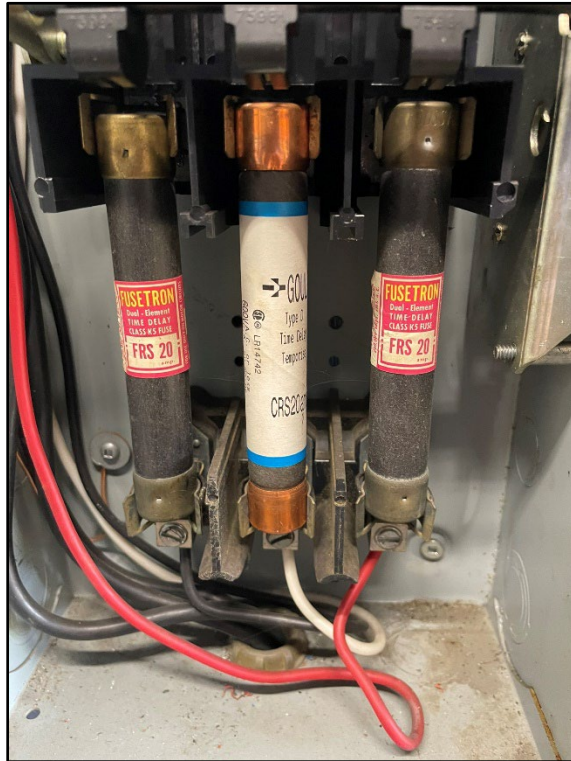
**Photo 11: More Non-Matching Fuses**

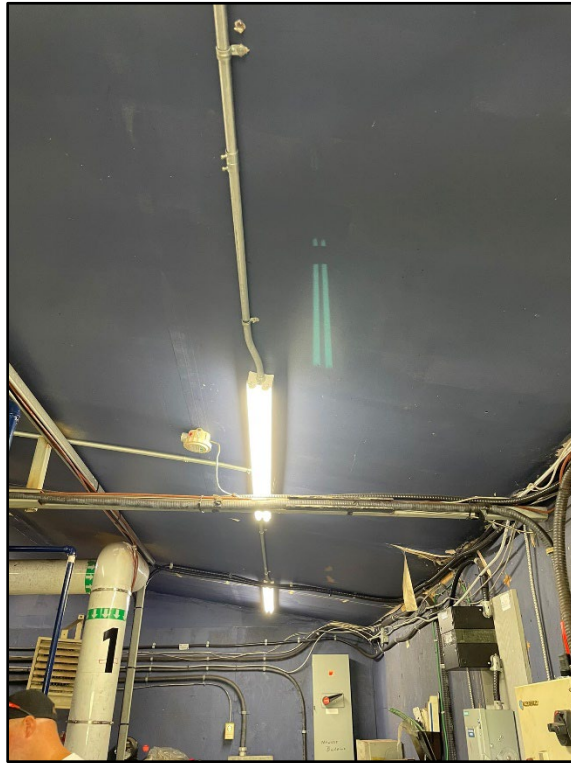
**Photo 13: Conduit Runs**

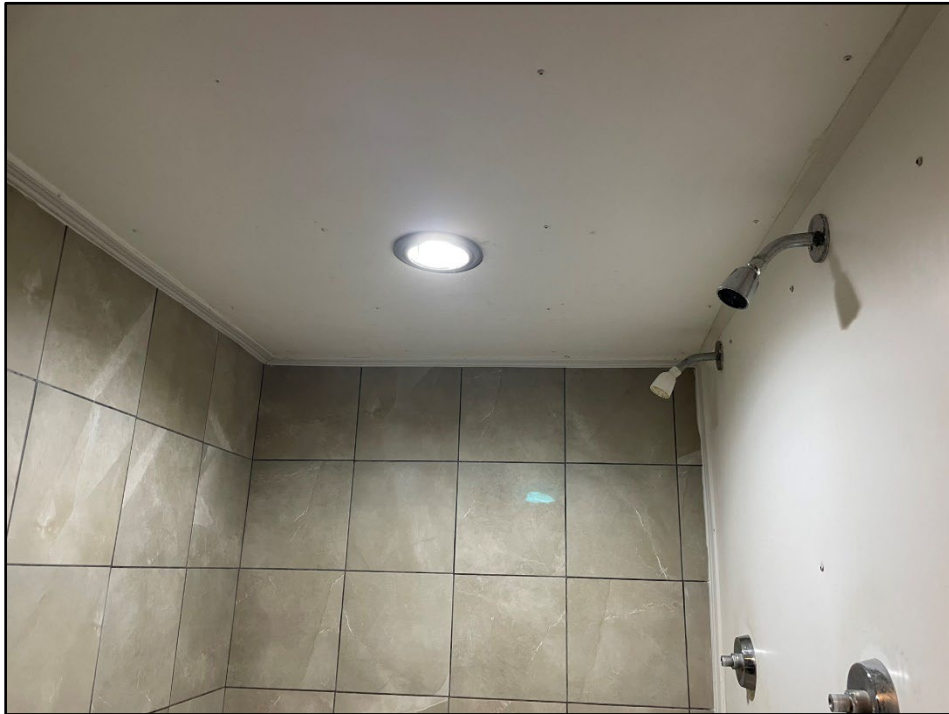
**Photo 15: Lighting Fixture in Shower**

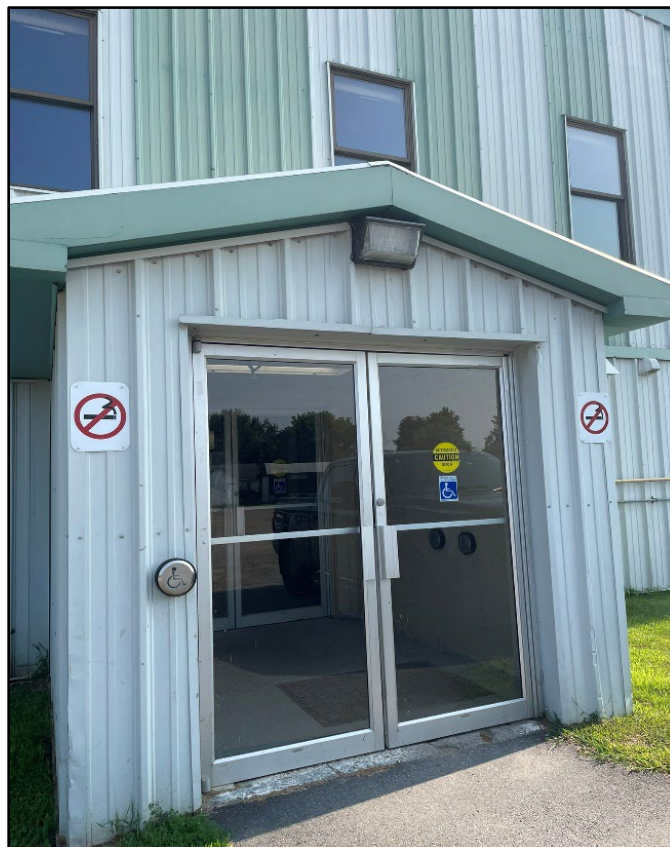
**Photo 16: Outdoor Wall Pack**

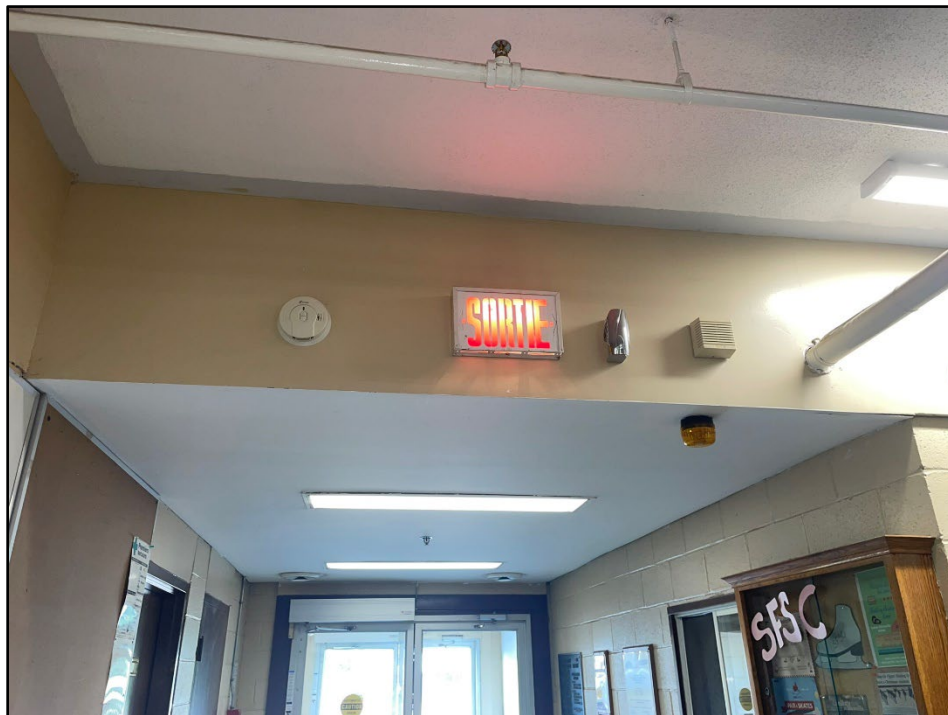
**Photo 18: Exit Signage**

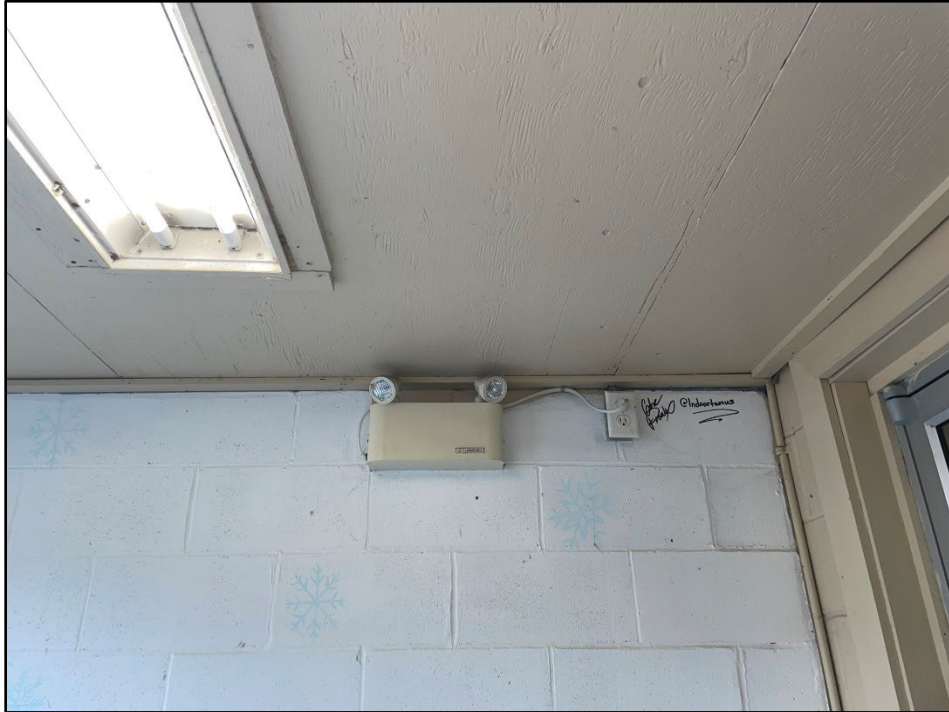
**Photo 19: EBU**

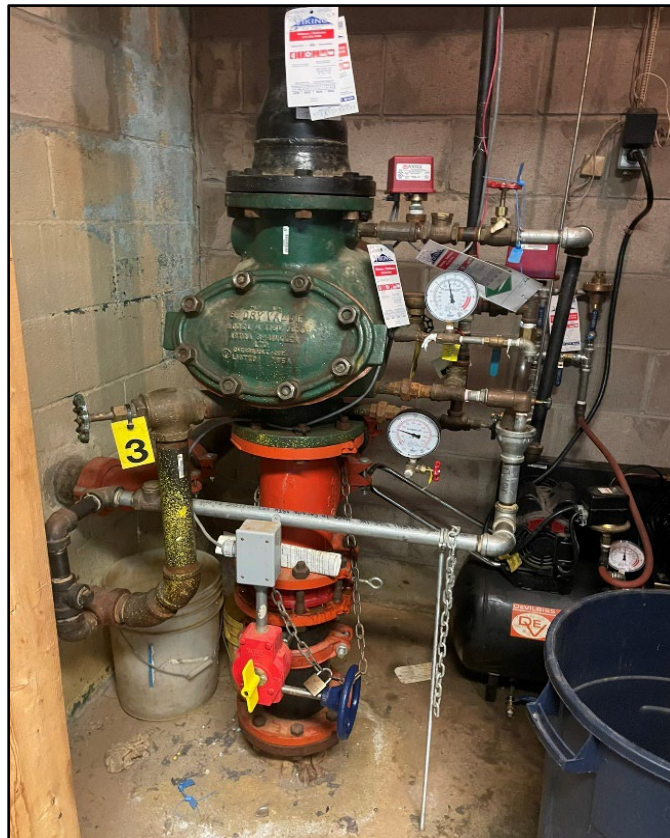
**Photo 20: Dry-Type Sprinkler System**

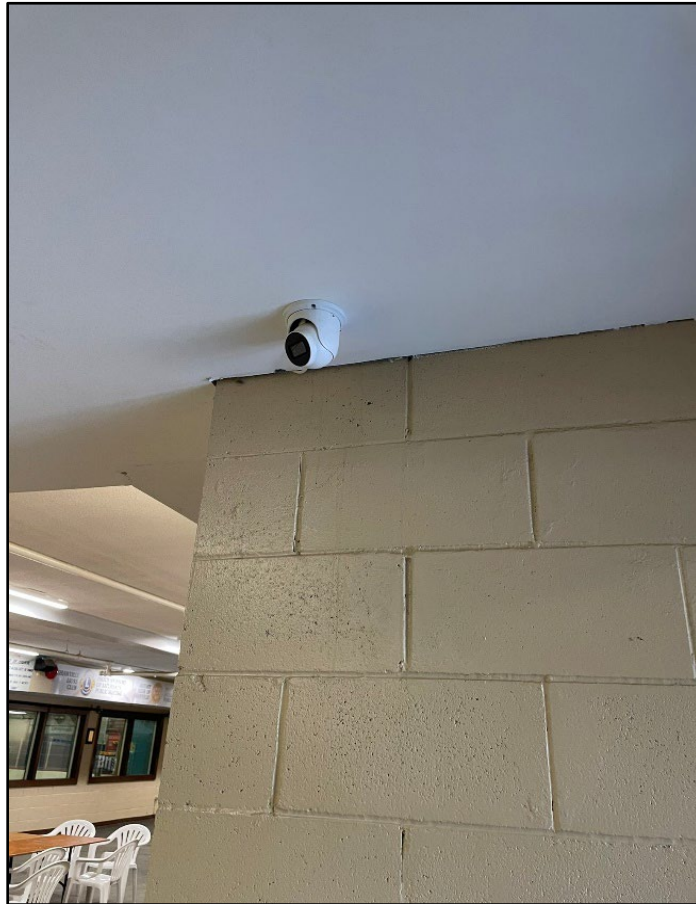
**Photo 23: Security Camera**
